IN THE COMMON PLEAS COURT OF MIAMI COUNTY, OHIO
GENERAL DIVISION

The Court hereby gives notice to the Parties that the report of the Court's Expert, Daniel Geers, P.E., S.E., of Jezerinac Geers & Associates, Inc., which was received on Monday, September 11, 2023, Court Exhibit I, is filed as part of the record. The report is attached hereto.

RE: 112-118 West Main Street (Tavern Building) Structural Assessment
JGA Project Number: 23.49.110

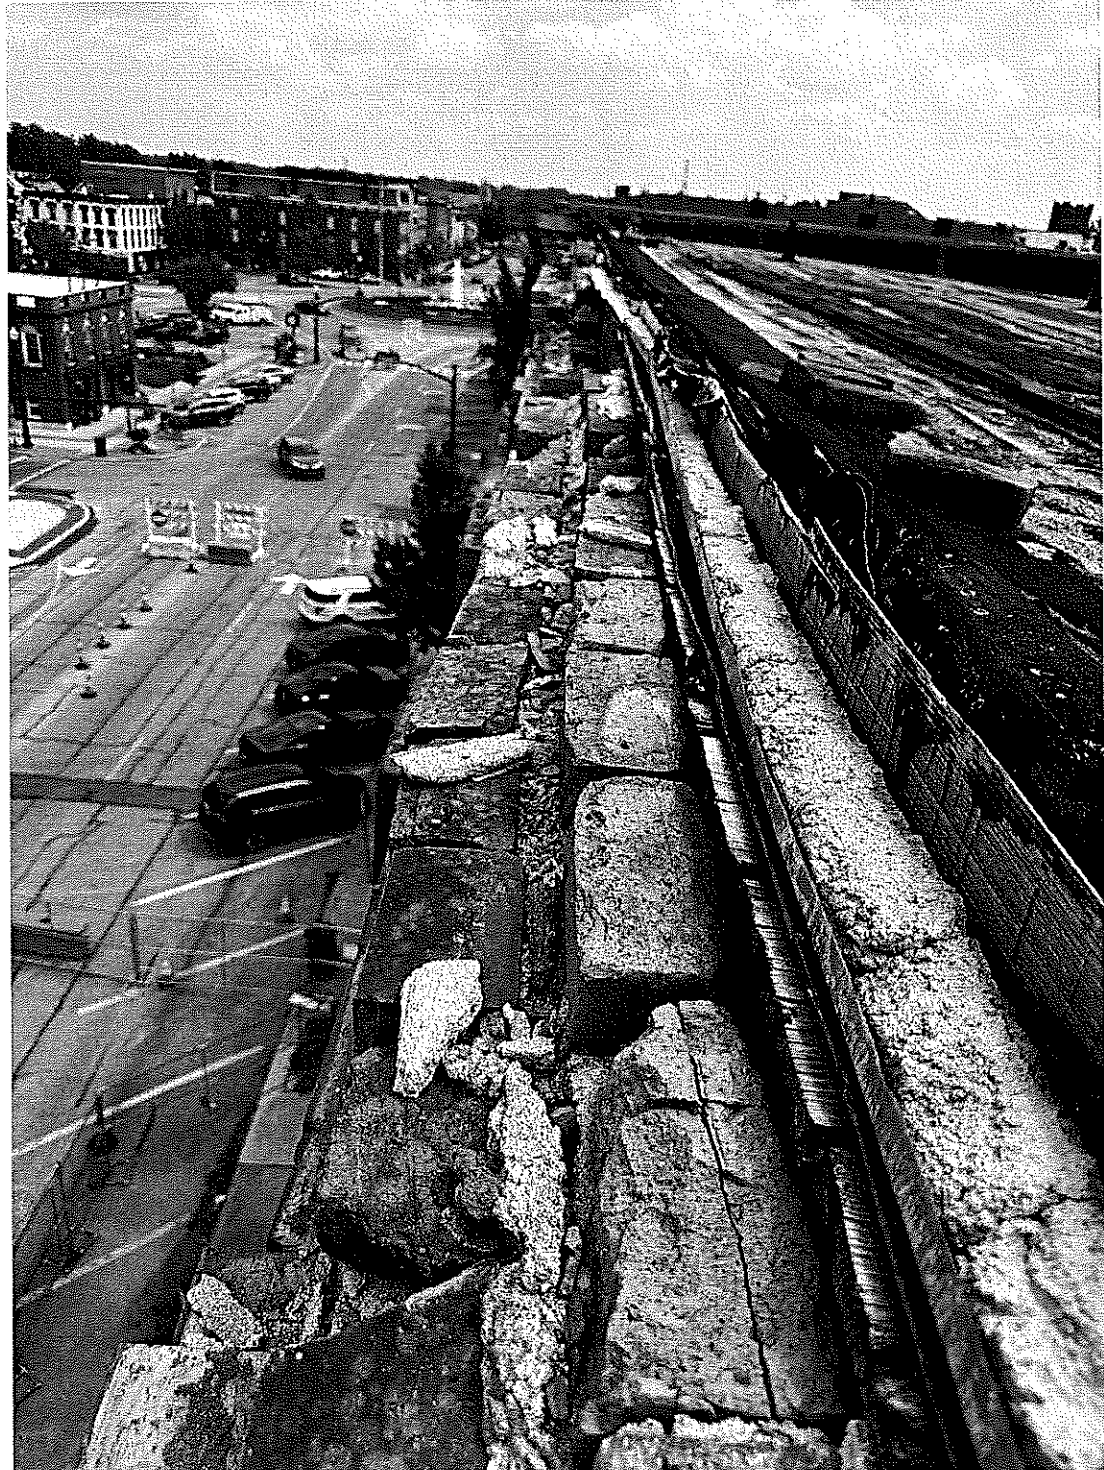
The roof of the North Building is a flat roof with a slight slope from north to south. A roof membrane is for the most part intact apart from a large section near the center of the north wall. At this section, the parapet has been damaged during a previous storm event and is missing. There appears to have been no effort made to repair this damage or secure loose bricks at the top of the wall. The wall and roof structure have been left exposed to the elements since the damage occurred (Photo 1 , Photo 2).

Photo 1 – North Building, North wall parapet damage looking East

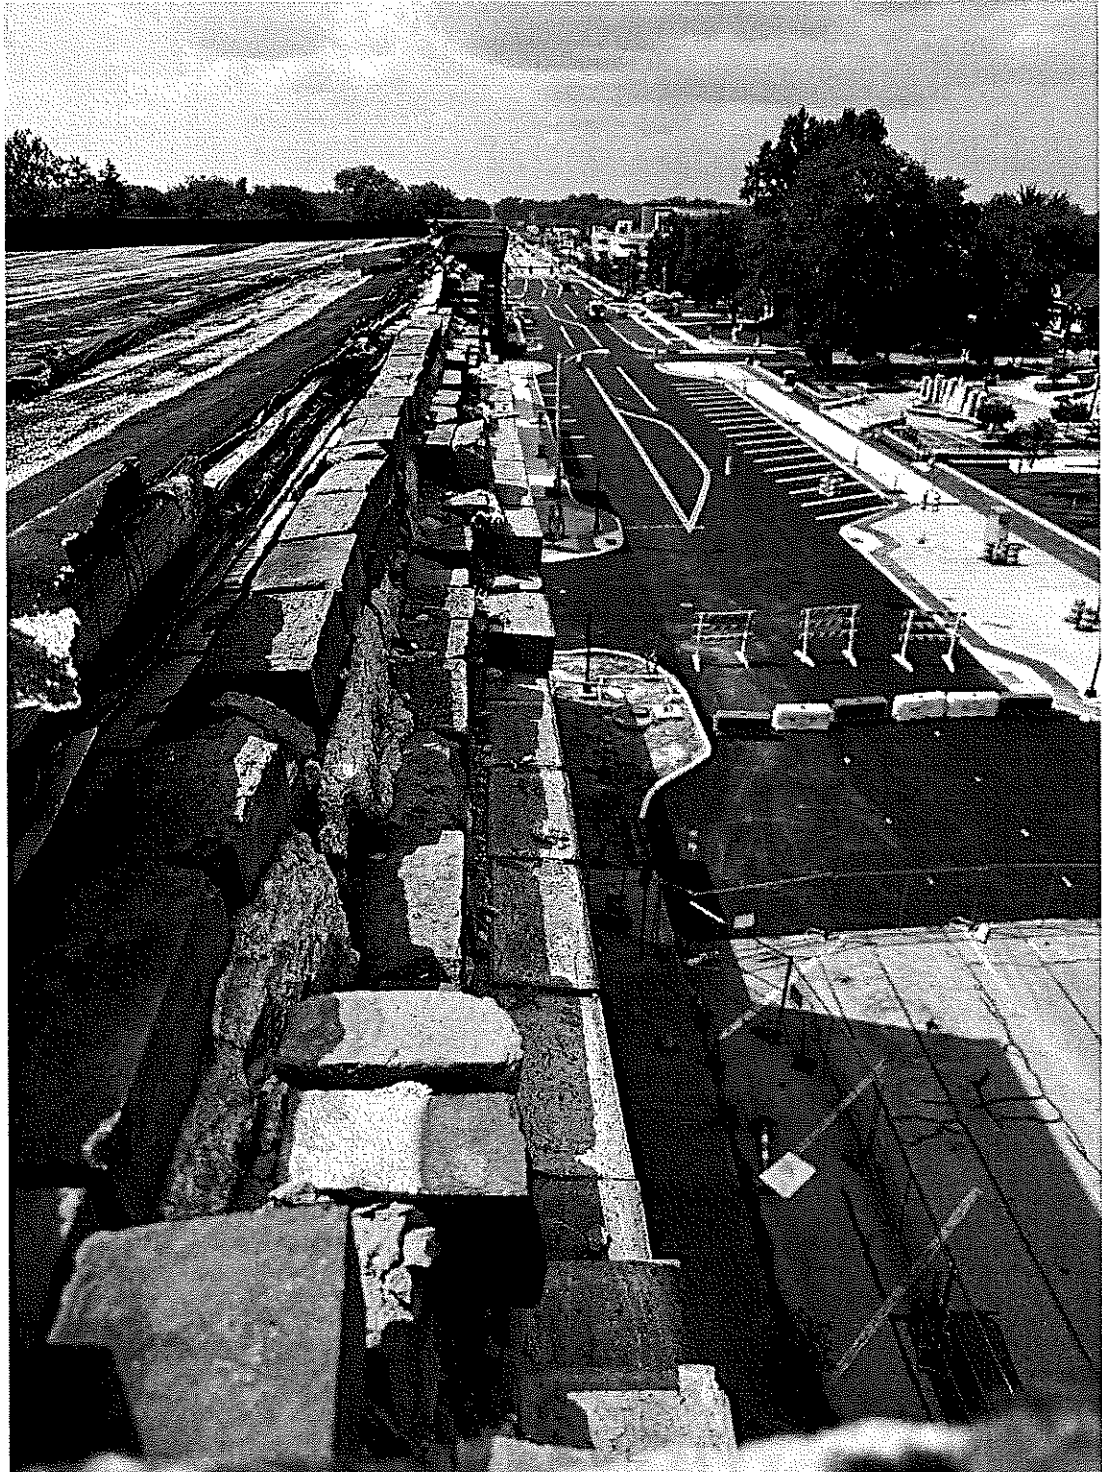
Photo 2 – North Building North wall parapet damage looking West

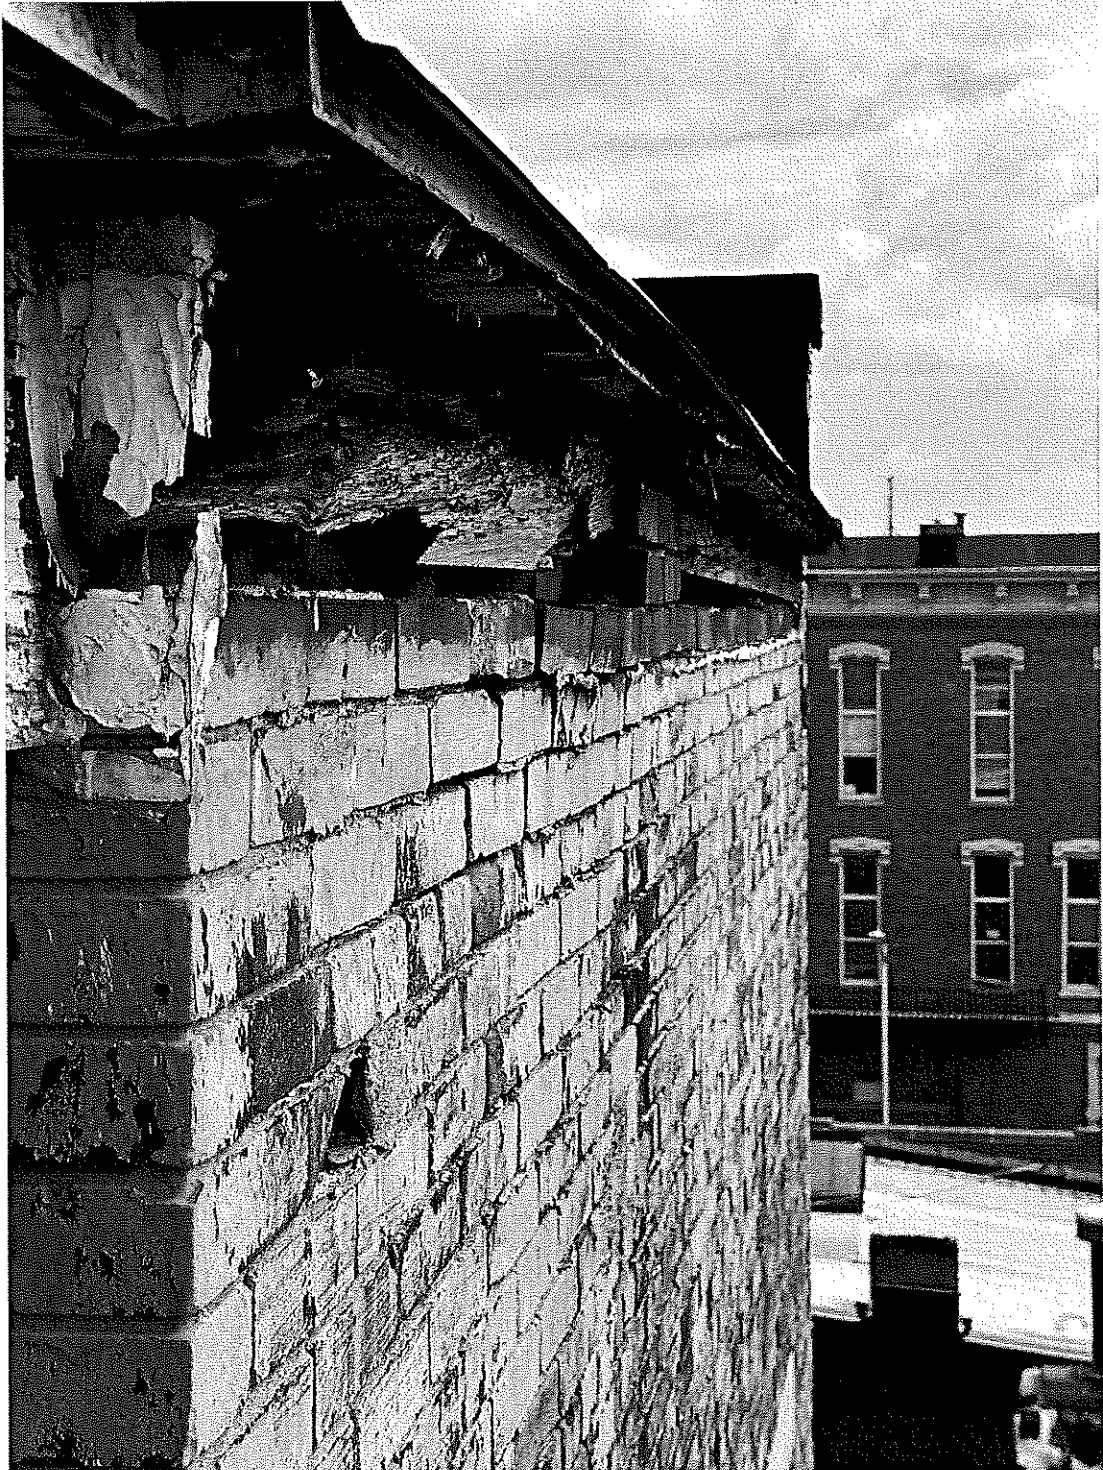
From the adjacent south building roof, the upper portion of the south wall of the north building was observed. At the southeast corner of the north building, it is observed that the top portion of the wall is in quite poor condition. There are large sections of missing wood fascia and many open and de-bonded mortar joints which have been left exposed to the elements for some time (Photo 3). From inside the building, there is clear evidence that water and birds have been entering the building freely for some time.

Photo 3 – North Building, South-East corner

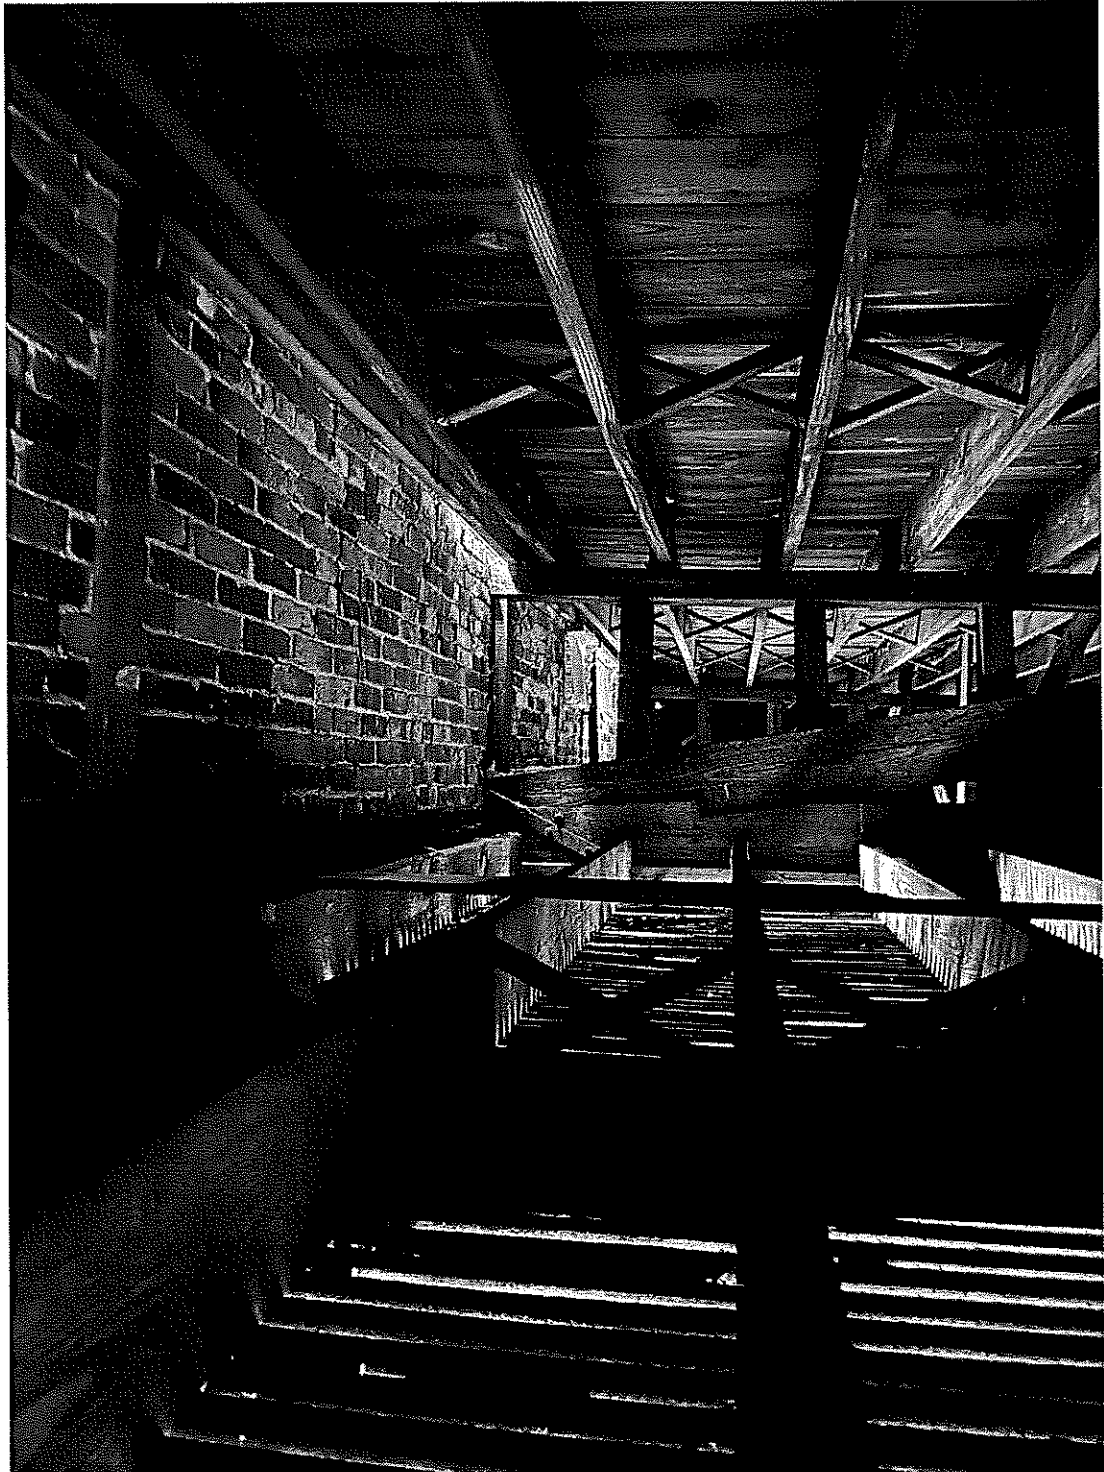
From an opening previously created in the ceiling at the north wall, the roof framing structure was observed. The roof framing of the north building consists of sloped top chord wood trusses spanning north-south at approximately 15' spacing, with wood roof joists between top chord and wood ceiling joists between bottom chords. This framing allows for a column free space at the third level. From within the ceiling space, it was observed that damage to the roof decking and roof structure has occurred because of uncontrolled water intrusion at the damaged parapet (Photo 4, Photo 5, Photo 6). The roof trusses appear to be in good condition considering their age and are bearing fully on the exterior wall. There was no observable anchorage of these trusses to the wall, and no intentional connection of the roof diaphragm to the exterior wall, which is common construction for buildings of this time period. While the truss end bearing was sound, it was evident that bricks surrounding the truss bearing have become loose over time, most likely due to the restraint the trusses impart on the mass masonry wall as the wall naturally tends to expand and contract to absorb and release moisture.

Photo 4 – North Building roof truss bearing at North wall.

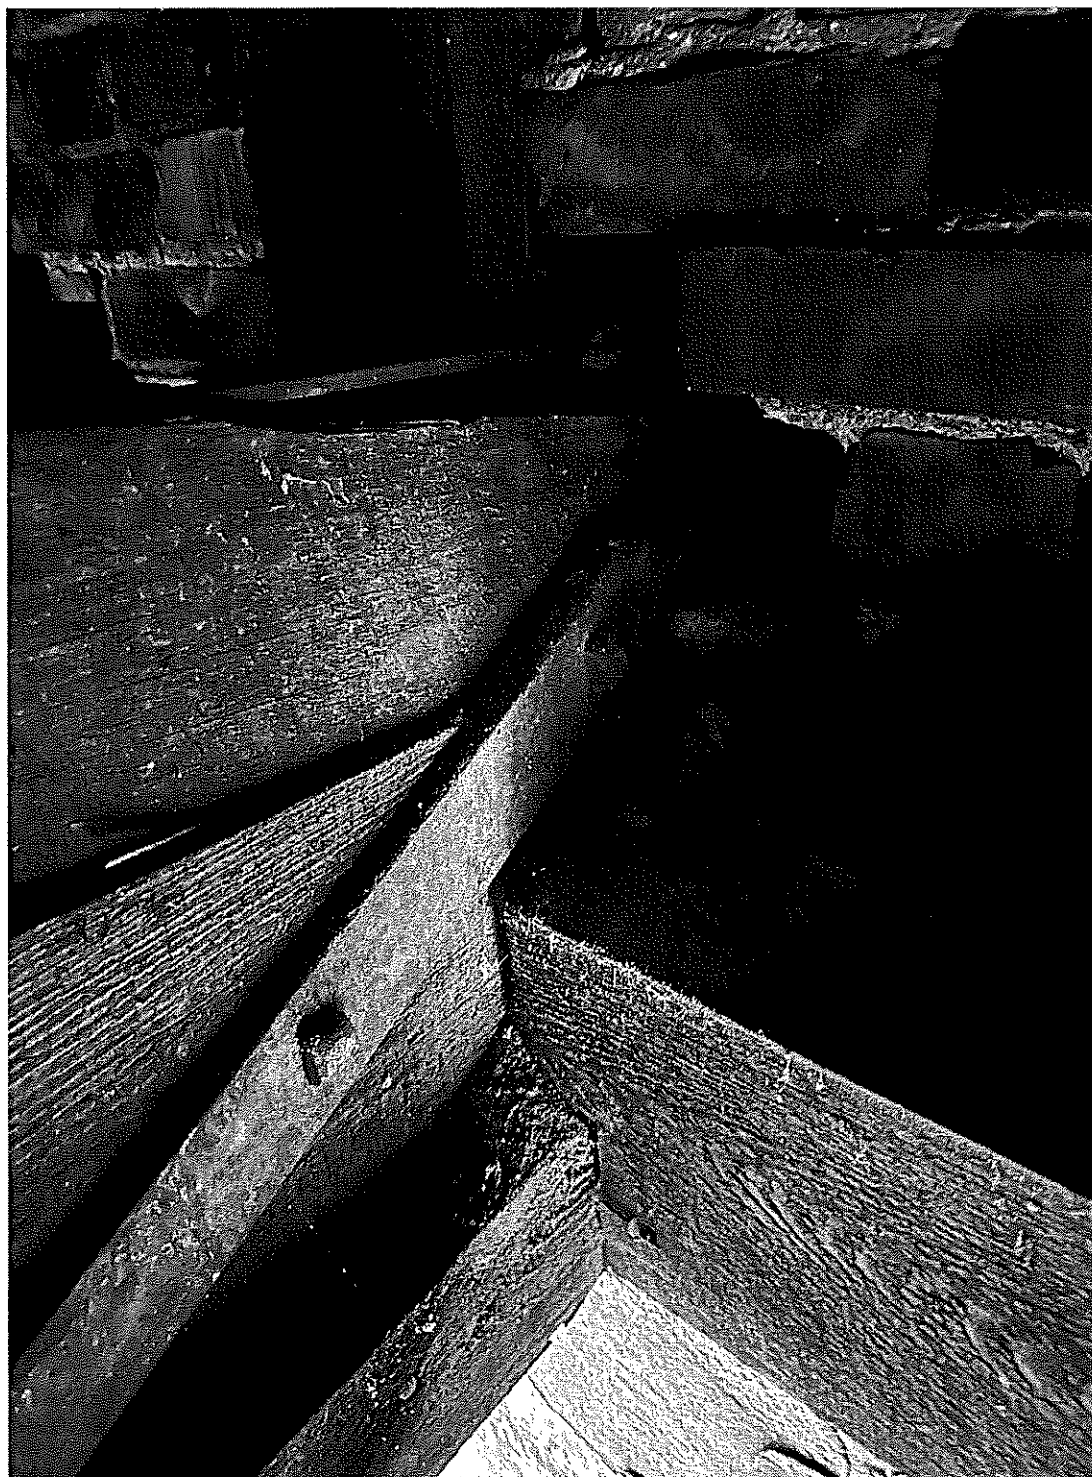
Photo 5 – North Building roof truss bearing at North wall.

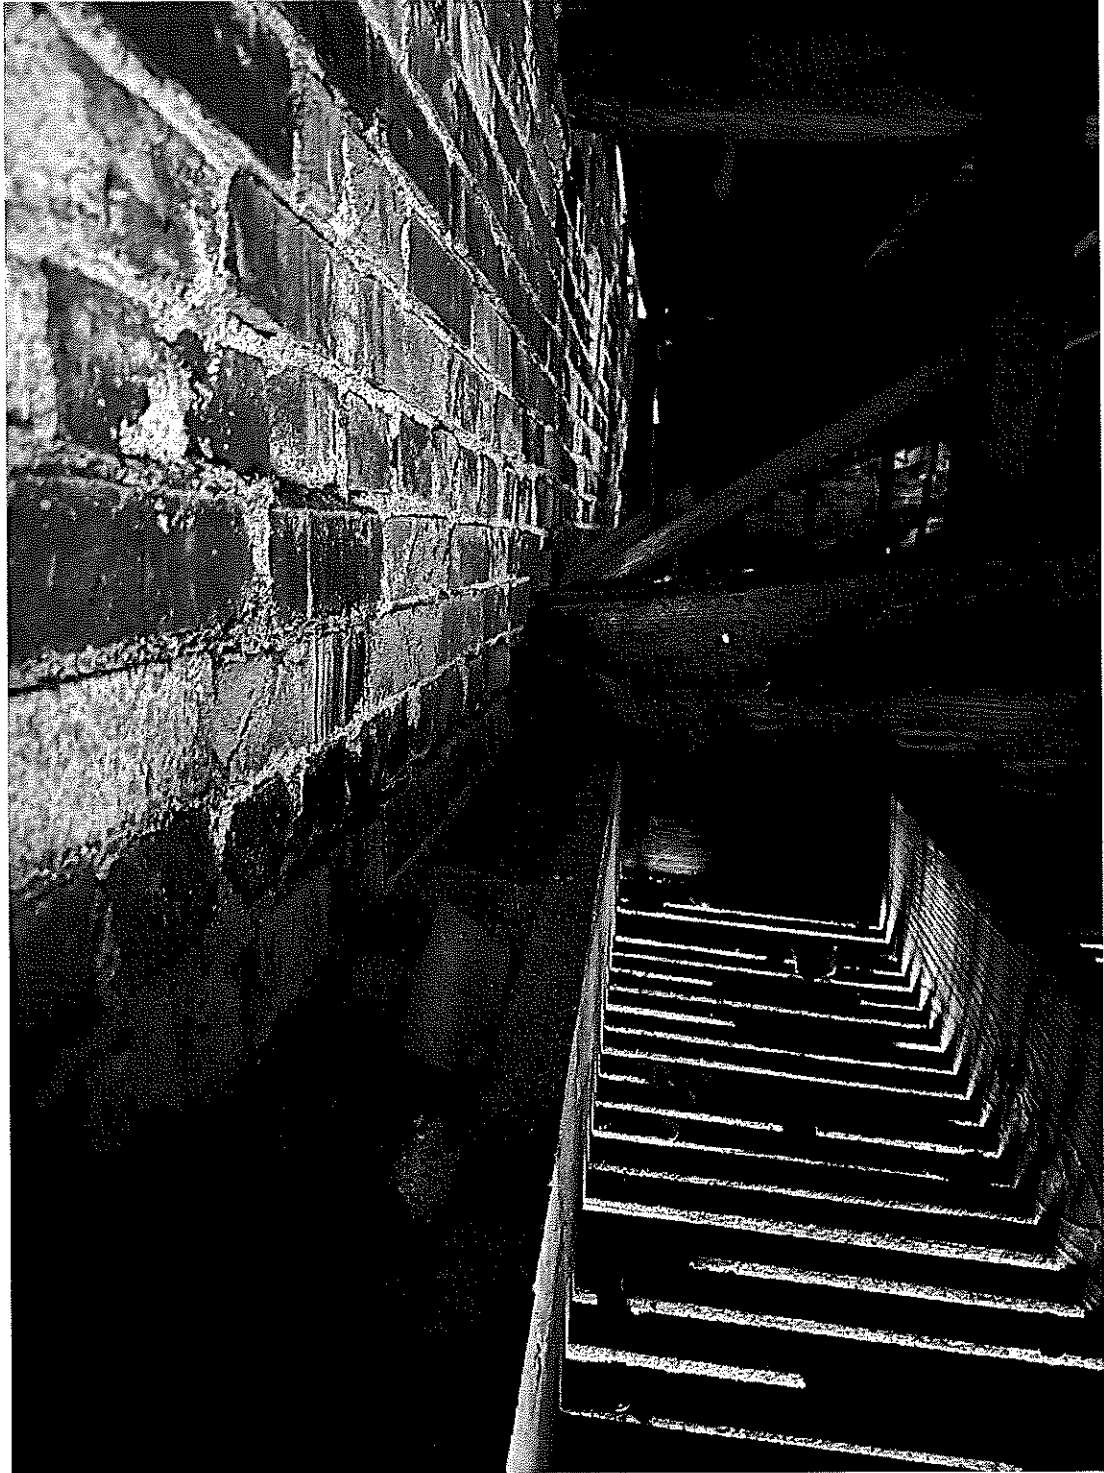
Photo 6 – North Building roof truss bearing at North Wall looking east.

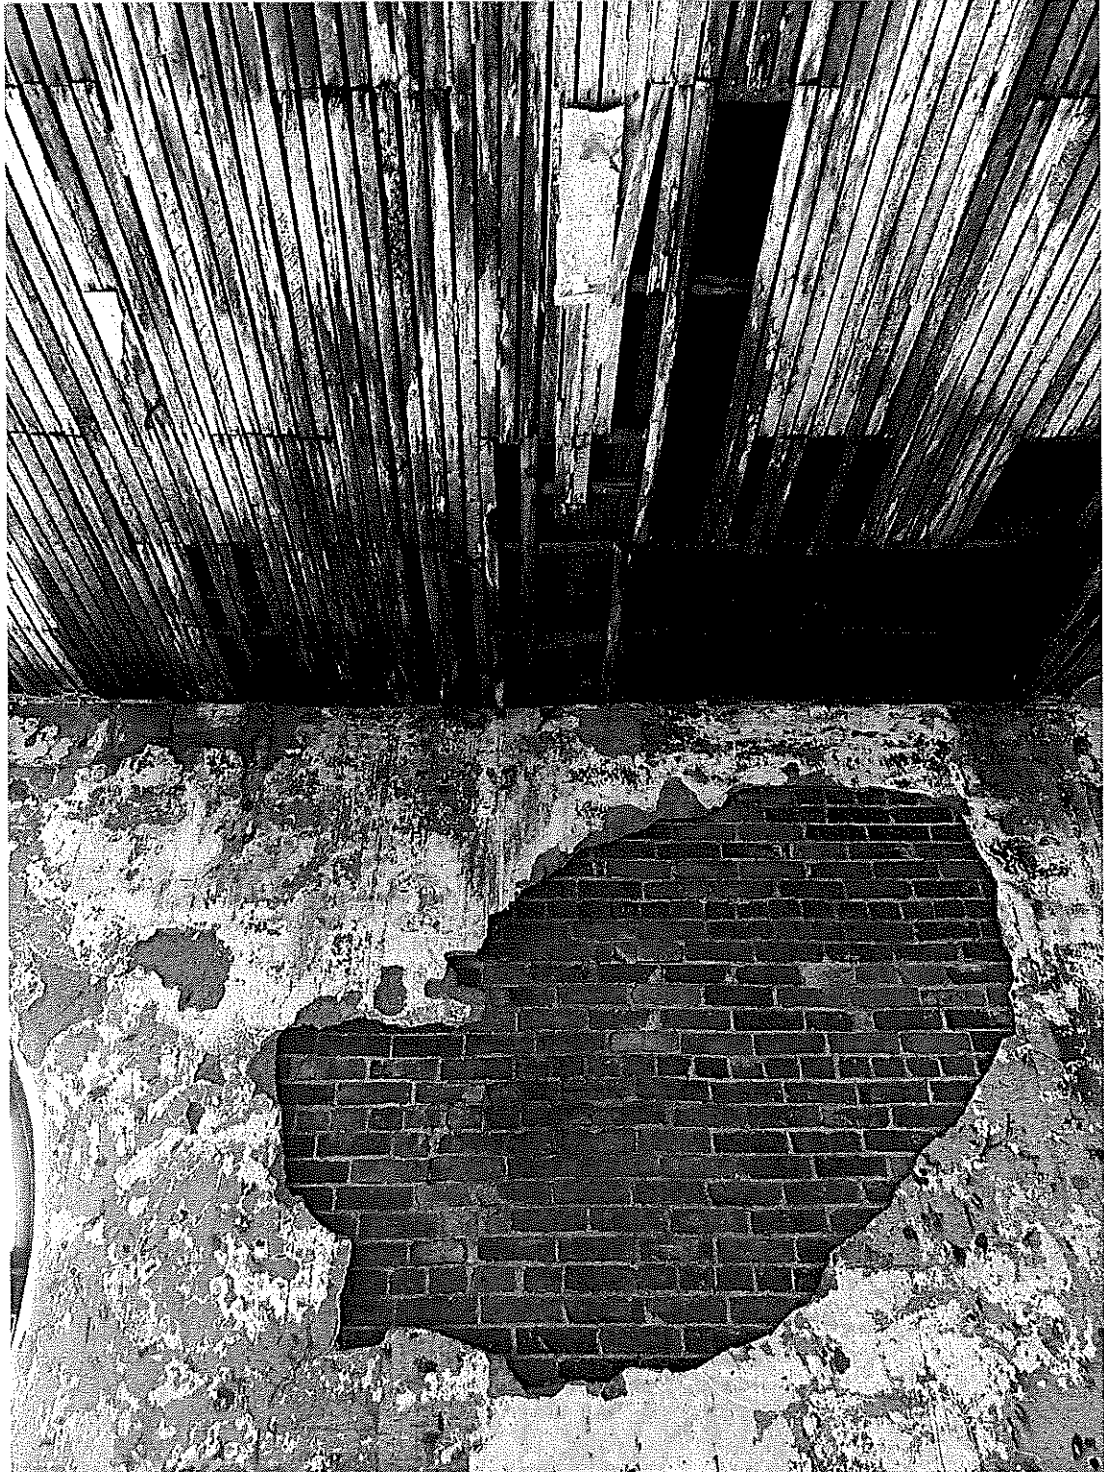
From the third floor, a large portion of the ceiling was observed to have moderate damage due to water intrusion at the north wall and portions of the ceiling plaster have fallen from the ceiling joists (Photo 7). Similarly, the water intrusion at the north wall has caused damage to the wall plaster at the exterior wall. The plaster is separated from the wall, and portions have fallen to the floor (Photo 7).

Photo 7 – Ceiling damage at North wall due to water infiltration.

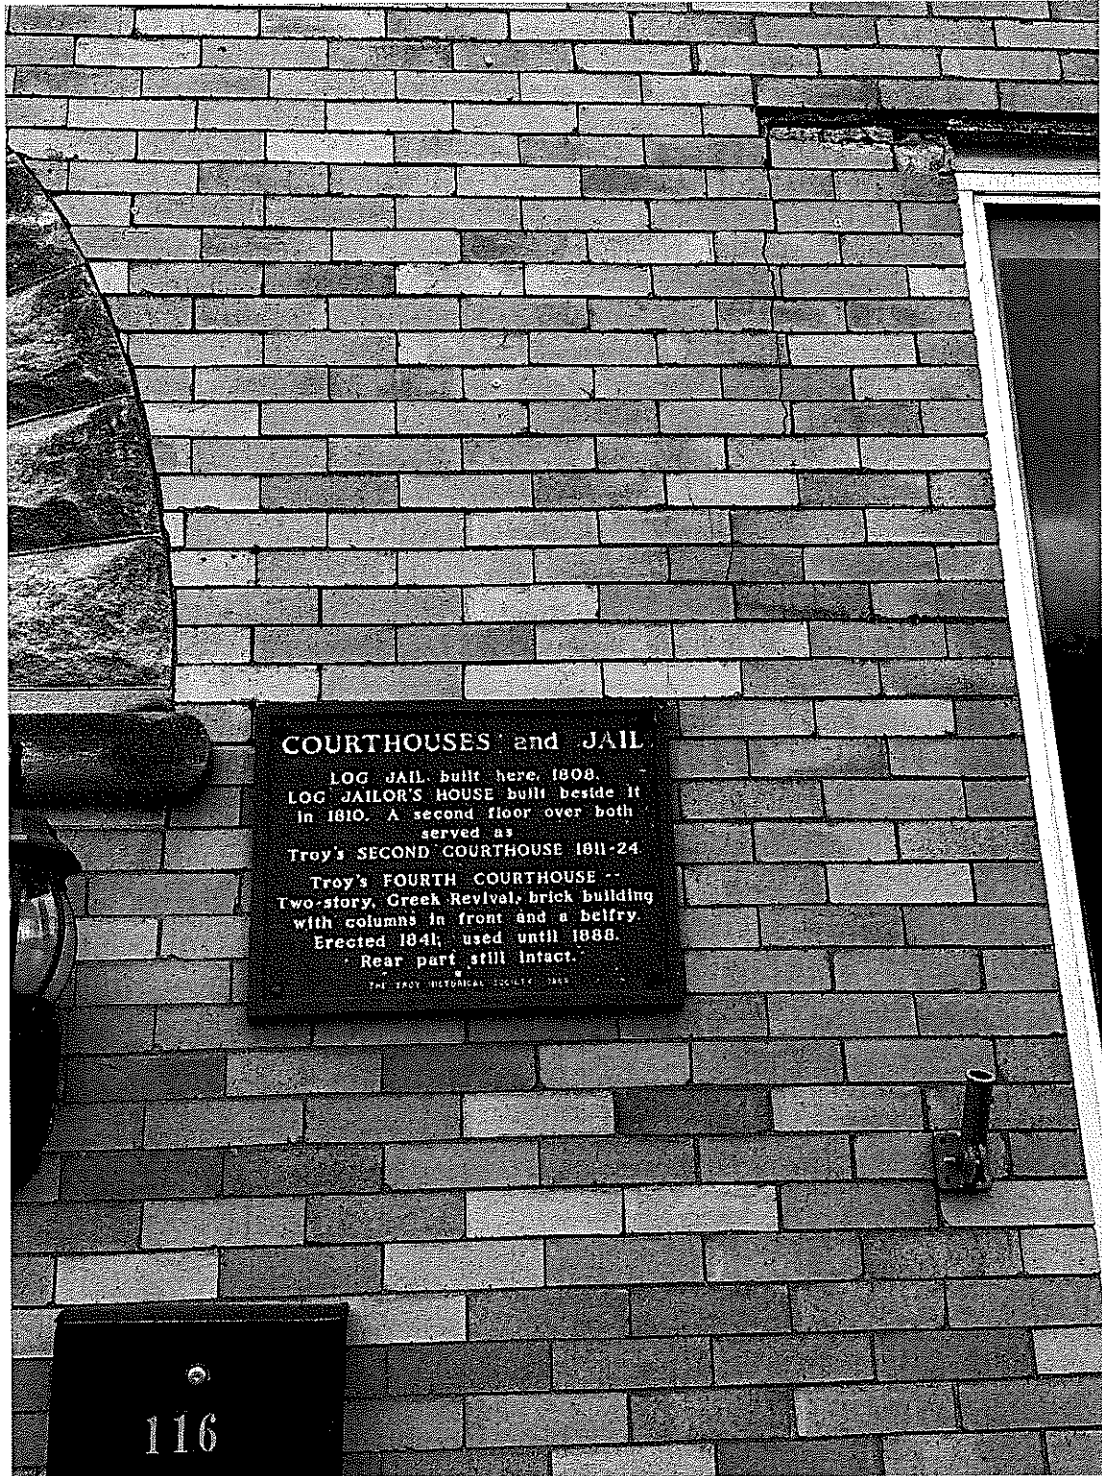
From the sidewalk along W. Main Street, the exterior façade was observed. It is noted that the outer layer of the exterior wall is a veneer layer and not part of the bearing wall assembly. This is evident by the different brick appearance, thinner mortar joints, and lack of bond coursing (brick headers) (Photo 8, Photo 9, Photo 10). Of concern with the veneer is how it is anchored to the mass masonry bearing wall. Commonly for buildings of its time, there was no mechanical anchorage between the bearing wall and the veneer layers, and the brick mortar alone performed this function. Over time, and with the constant expansion and contraction of these types of walls, this mortar bond can weaken or become completely fractured. The only way to verify this anchorage is by disassembling a portion of wall to investigate.

Photo 8 – Exterior Veneer at North wall.

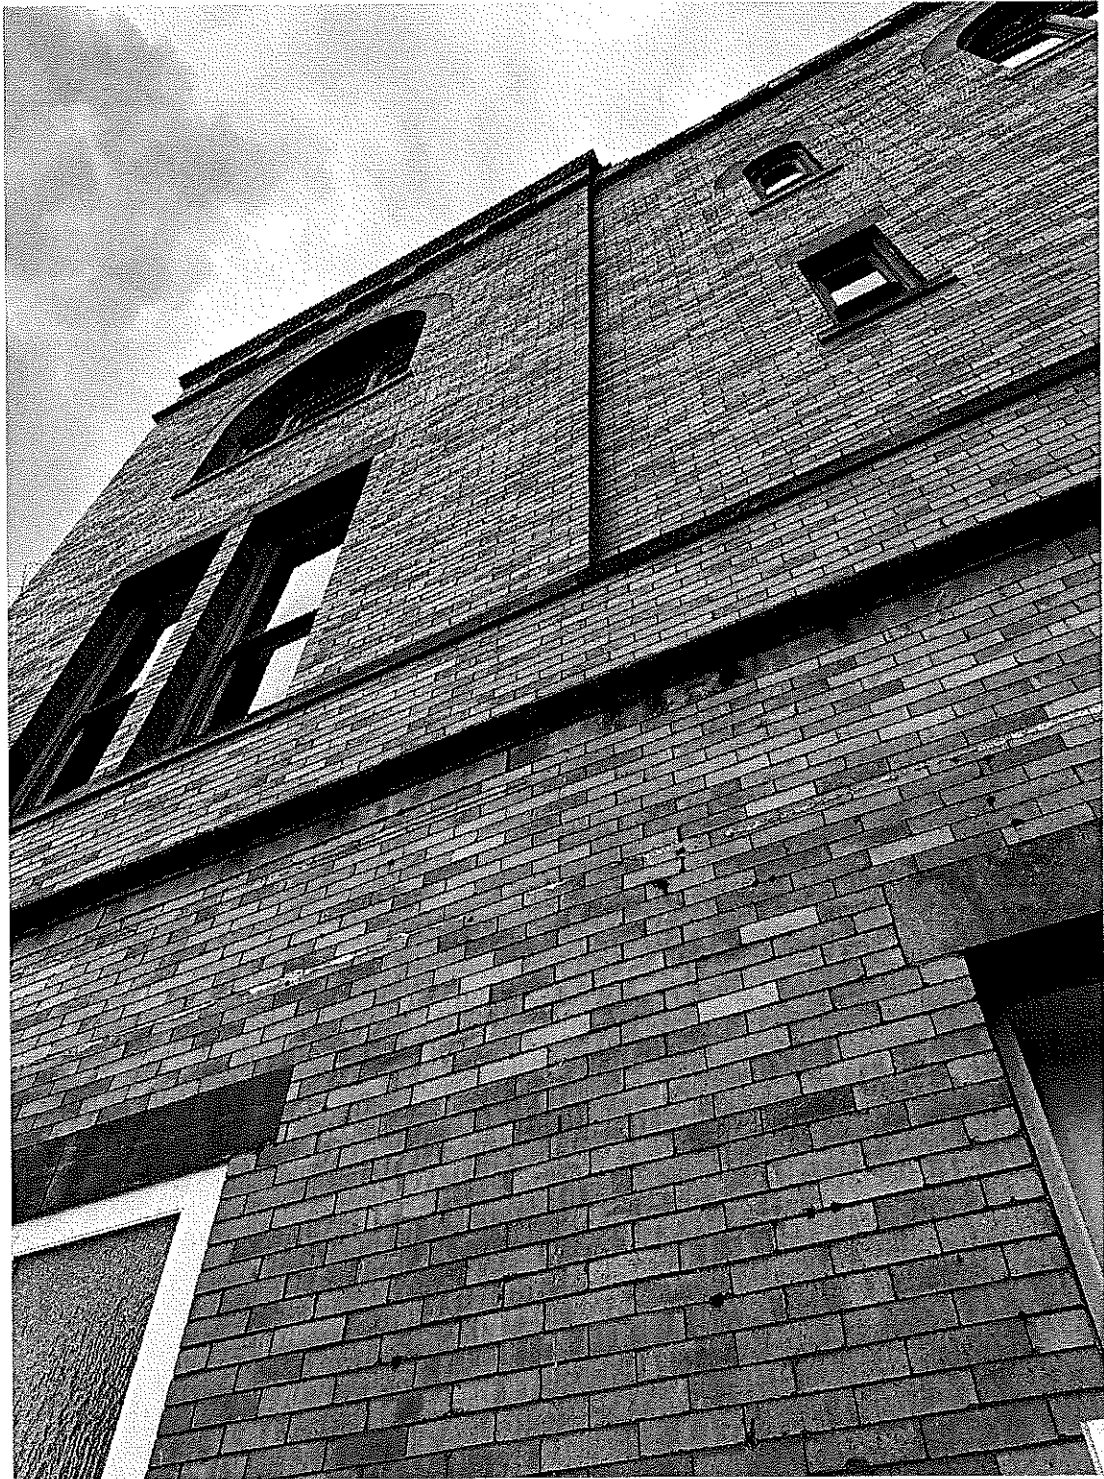
Photo 9 - Exterior Veneer at North wall

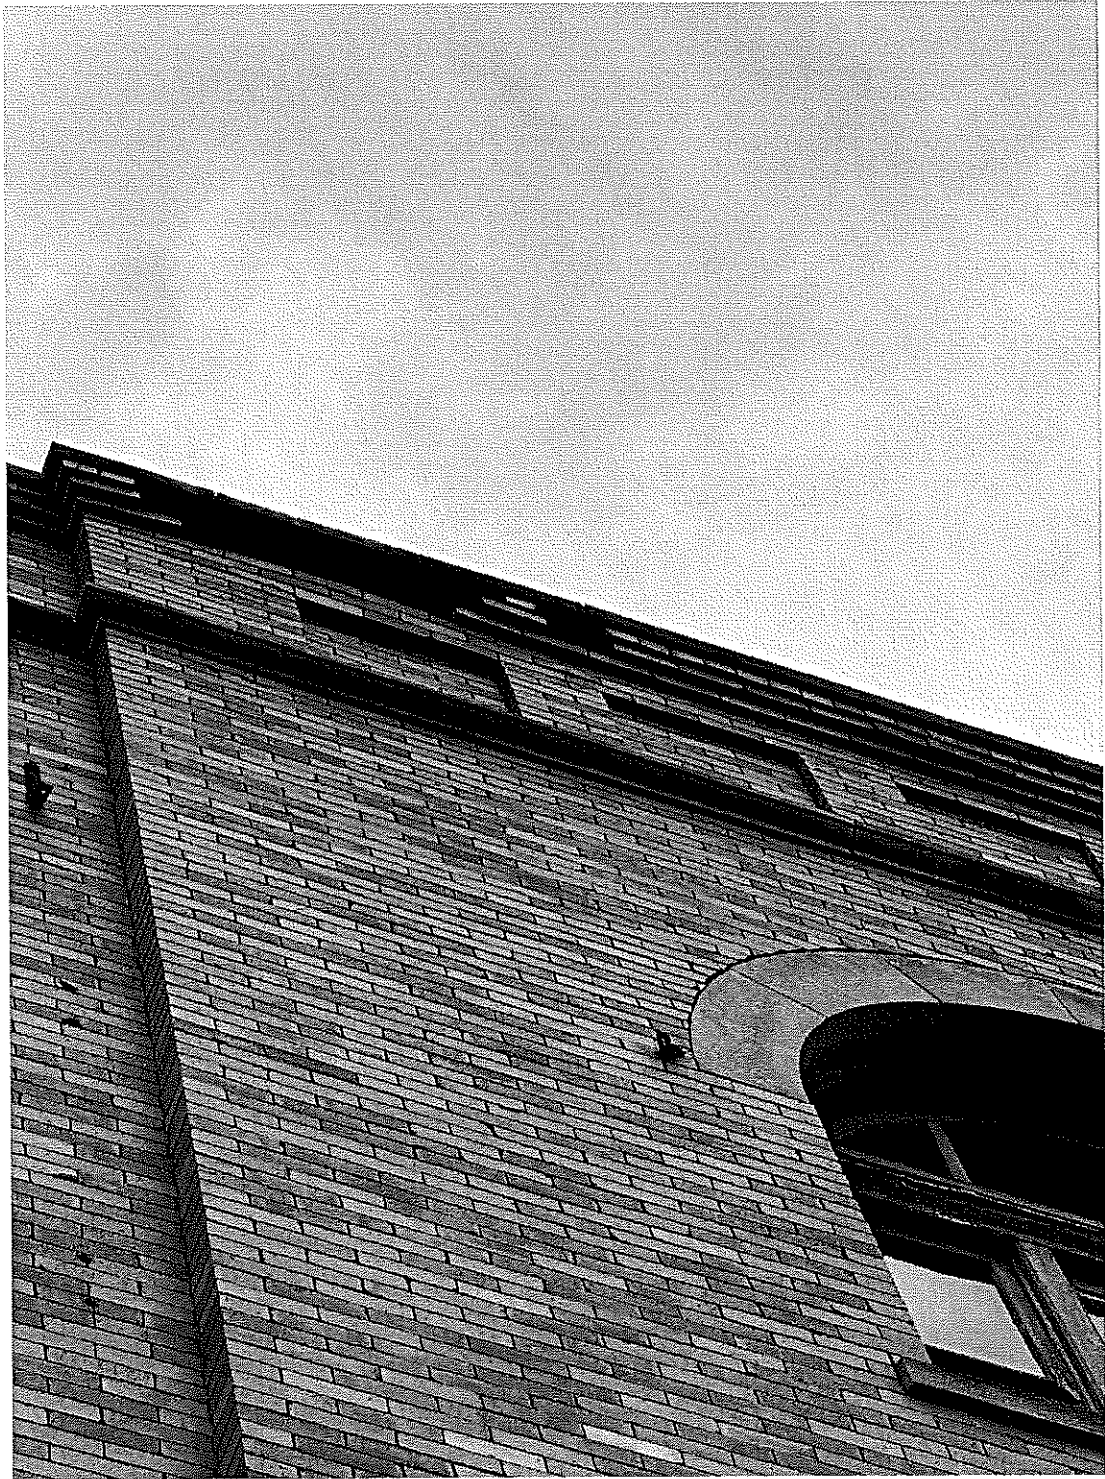
Photo 10 - Exterior Veneer at North wall, top of wall damage.

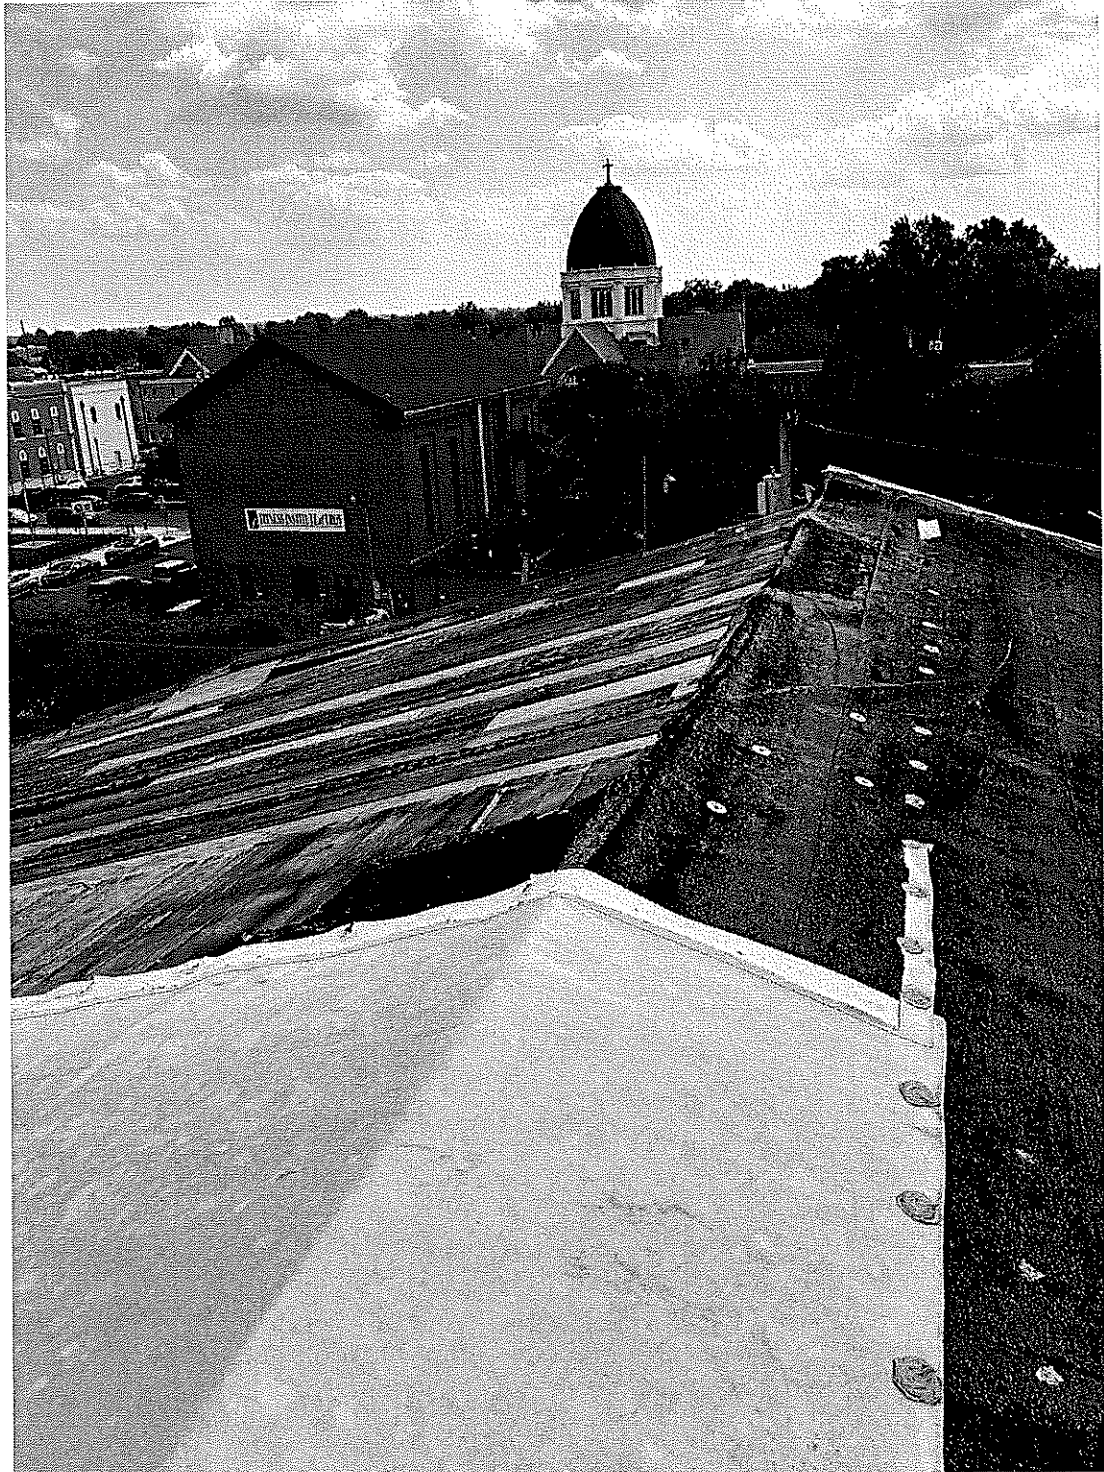
The condition of the roof of the South Building is very poor, particularly in the southeast quadrant. The roof sustained damage at some point and no attempt to repair or protect the structure has been made since the damage occurred (Photo 11). There was not a level of comfort sufficient to walk across much of this roof, so observations were primarily made from within the attic / truss space below.

Photo 11 - South Building roof looking South at missing roofing.

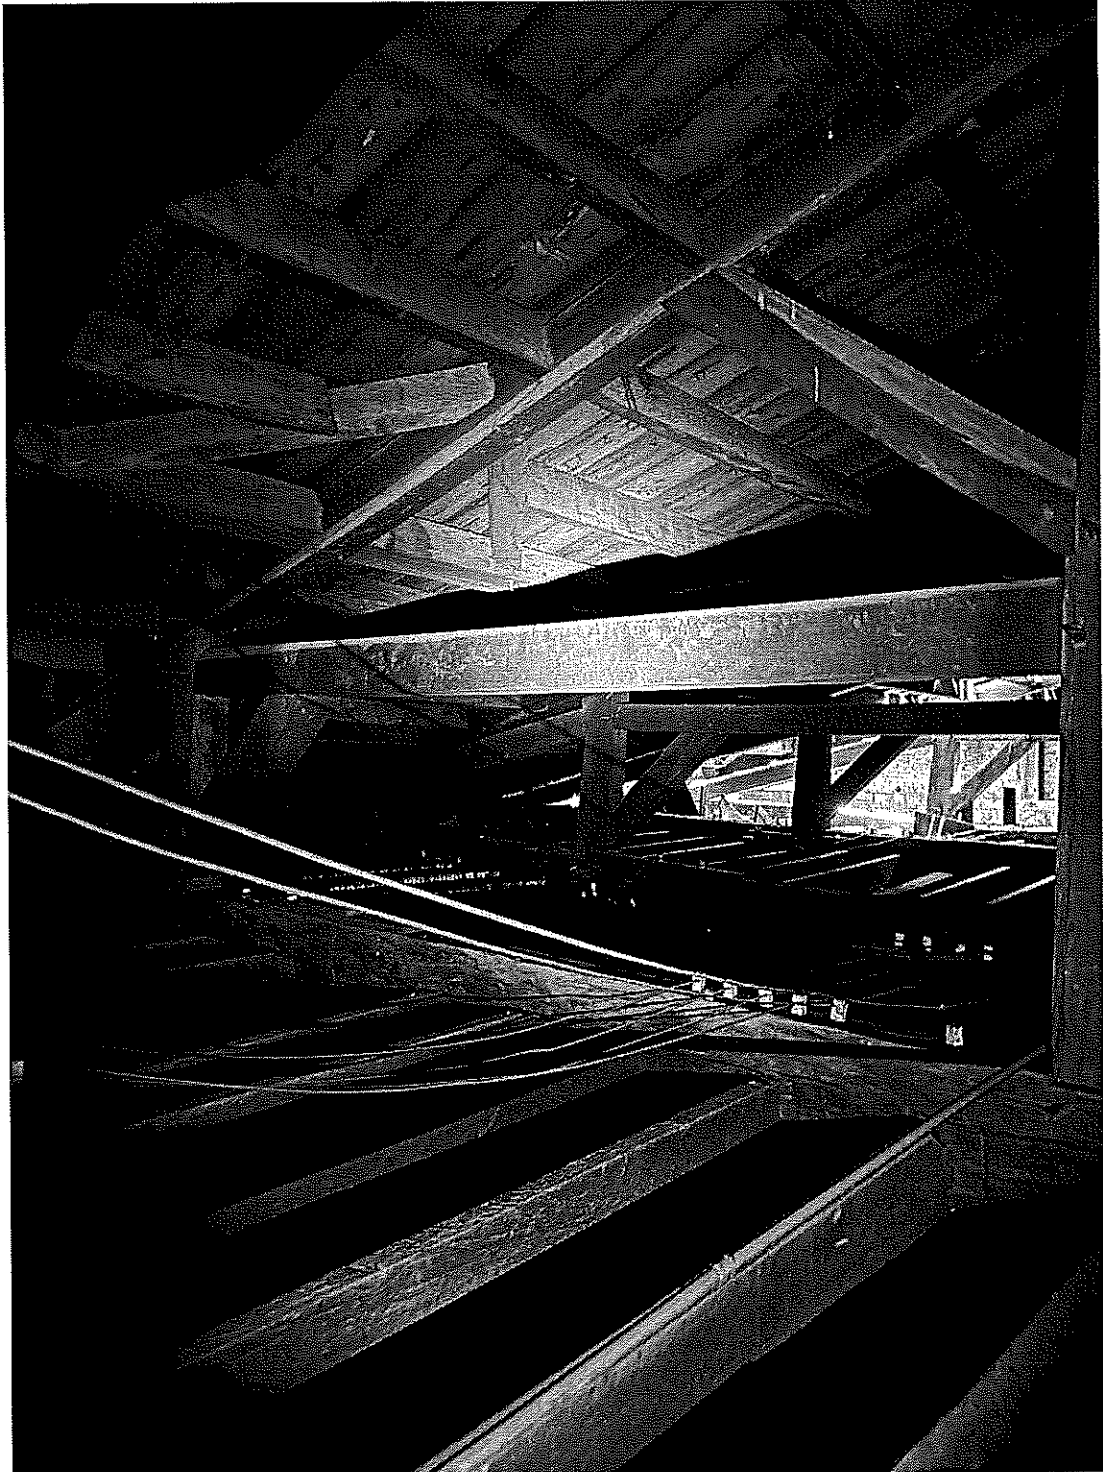
From the attic space, it was determined that the roof structure of the south building is comprised of primary heavy timber (king post over queen post) roof trusses spanning East-West between mass masonry bearing walls. The trusses span approximately 50' and are spaced at approximately 8' on center. Wood roof joists span between the principal rafters of the king post truss and wood ceiling joists span between the bottom chord, or tie beam portion of the king post truss. All joints in these trusses, with the exception of the bottom tie beam connections, are compression (Bearing) connections. Wood pegs visible are used to hold the trusses together when unloaded, but when loaded, the connections are in bearing and the pegs are not intended or required to transfer load. The bottom chord tie beam is connected to the verticals using metal "U" straps around the bottom of the beam and bolted through the vertical tension members. There is some separation between the wood members of these tension joints, but the load path through the straps bolted into the verticals appear to be performing and transferring the loads as intended in the design (Photo 12, Photo 13, Photo 14).

Photo 12- South Building Truss, East half

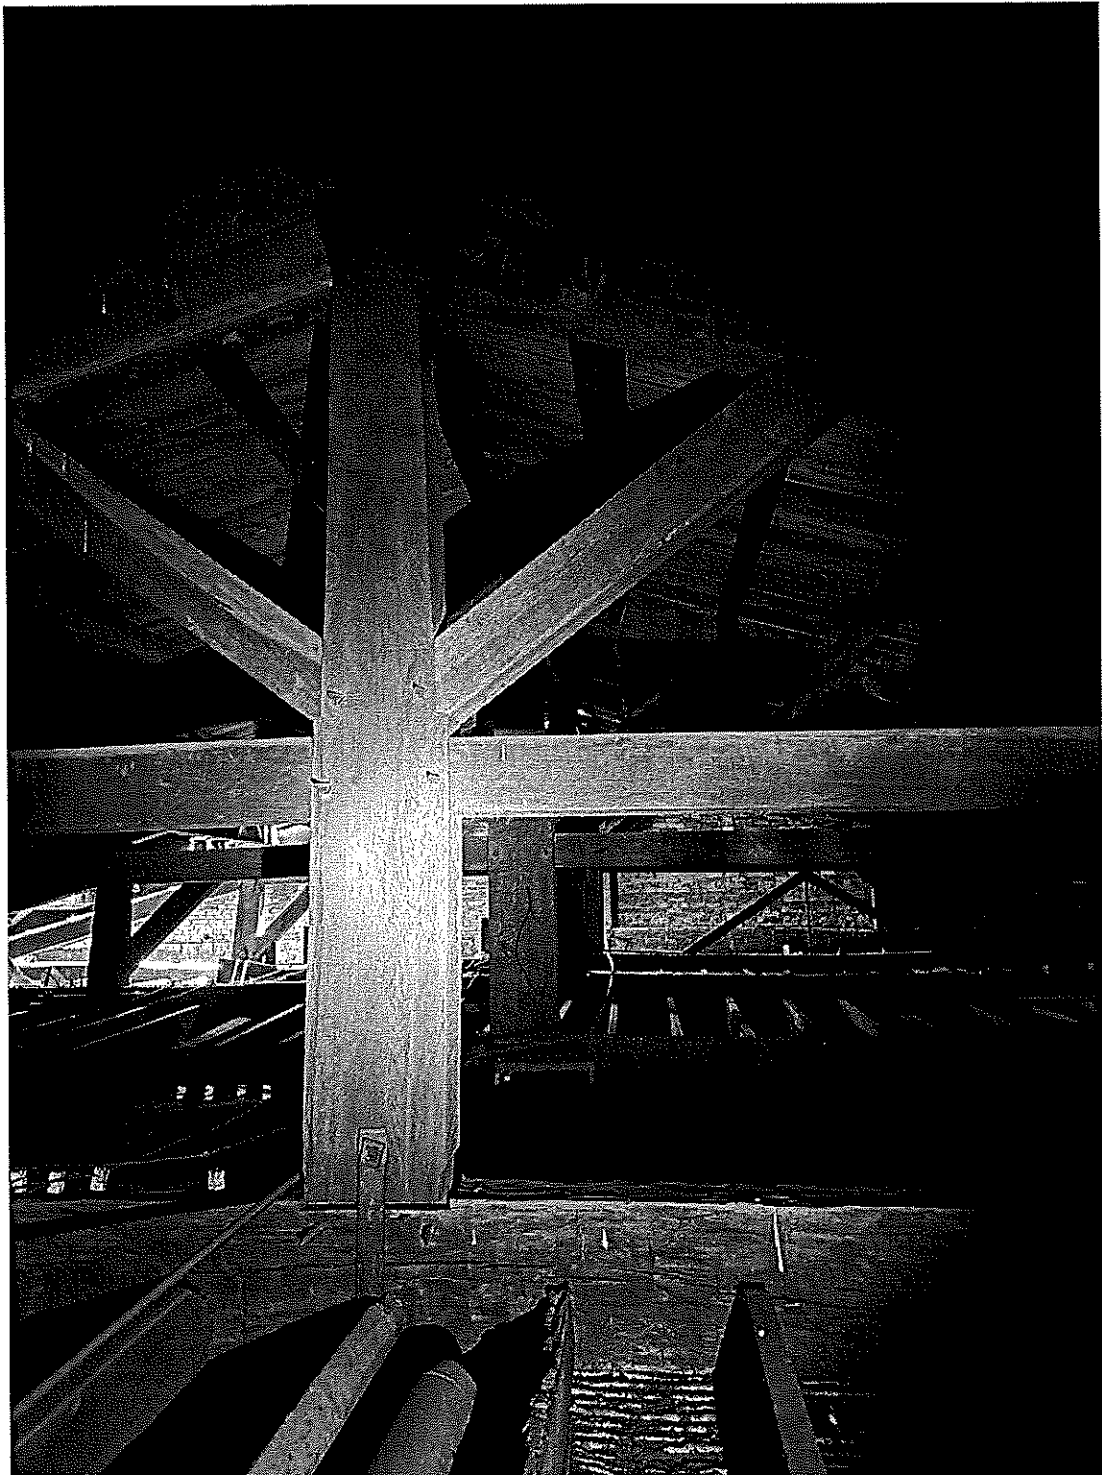
Photo 13 - South Building Truss, center
