IN THE COMMON PLEAS COURT OF MIAMI COUNTY, OHIO
GENERAL DIVISION

The Court hereby gives notice to the Parties that the report of the Court's Expert, Daniel Geers, P.E., S.E., of Jezerinac Geers & Associates, Inc., which was received on Monday, September 11, 2023, Court Exhibit I, is filed as part of the record. The report is attached hereto.

RE: 112-118 West Main Street (Tavern Building) Structural Assessment
JGA Project Number: 23.49.110

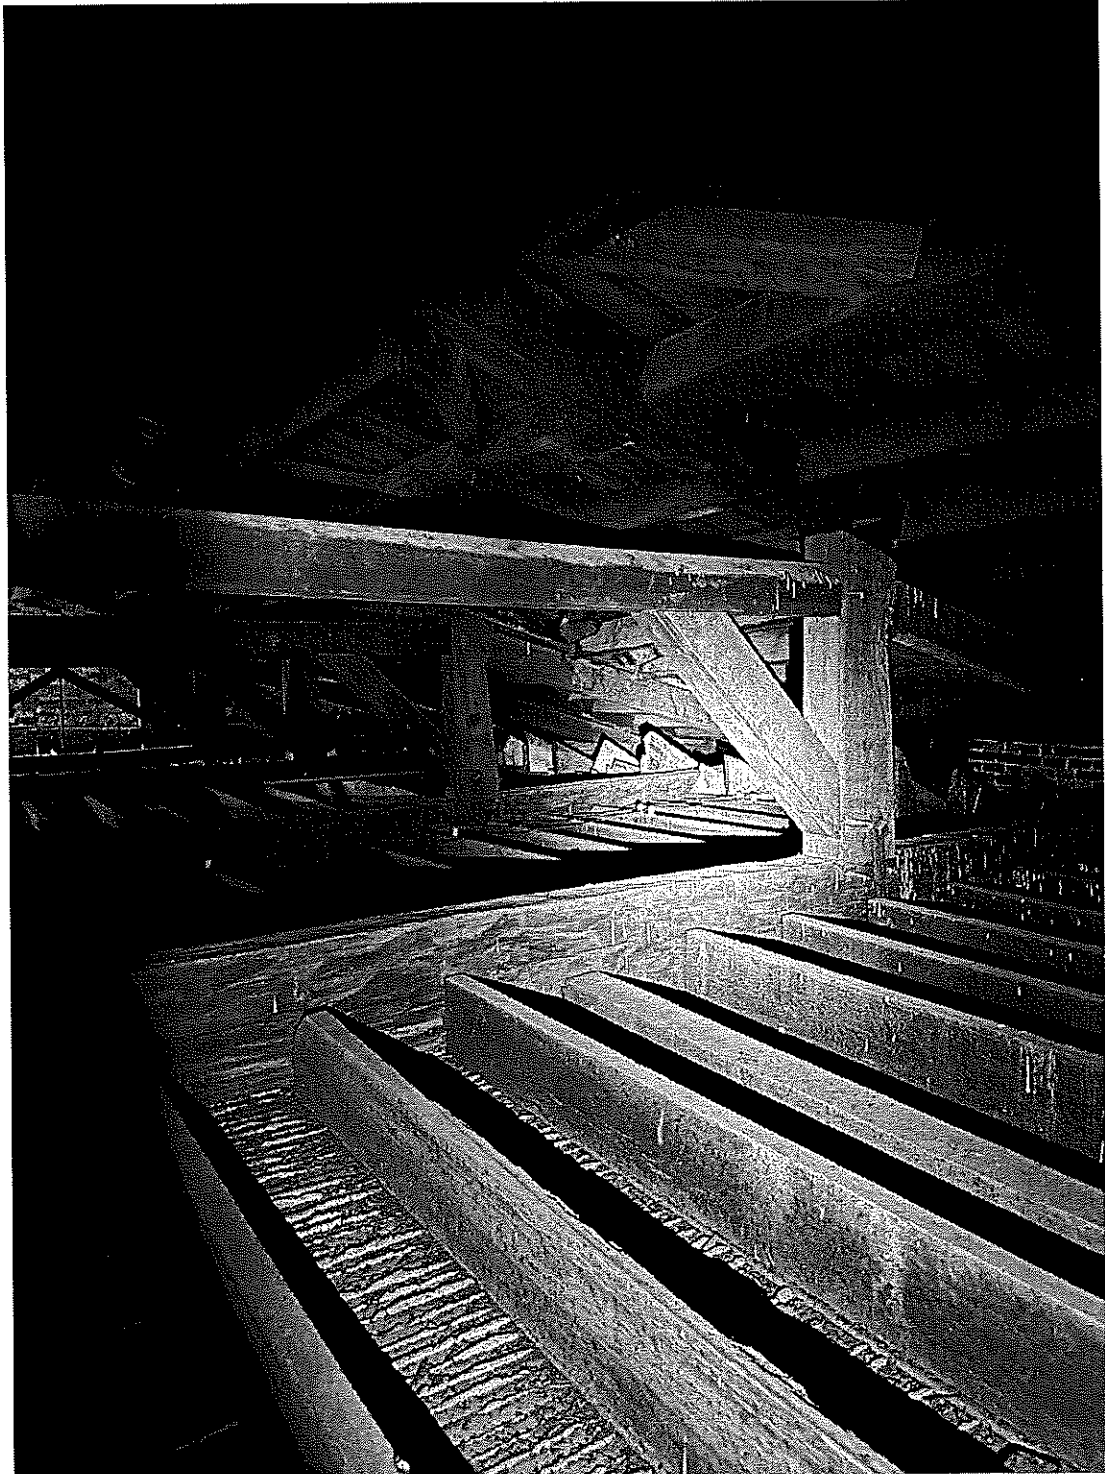
From the attic space, it was determined that the roof structure of the south building is comprised of primary heavy timber (king post over queen post) roof trusses spanning East-West between mass masonry bearing walls. The trusses span approximately 50' and are spaced at approximately 8' on center. Wood roof joists span between the principal rafters of the king post truss and wood ceiling joists span between the bottom chord, or tie beam portion of the king post truss. All joints in these trusses, with the exception of the bottom tie beam connections, are compression (Bearing) connections. Wood pegs visible are used to hold the trusses together when unloaded, but when loaded, the connections are in bearing and the pegs are not intended or required to transfer load. The bottom chord tie beam is connected to the verticals using metal "U" straps around the bottom of the beam and bolted through the vertical tension members. There is some separation between the wood members of these tension joints, but the load path through the straps bolted into the verticals appear to be performing and transferring the loads as intended in the design (Photo 12, Photo 13, Photo 14).

Photo 14 - South Building Truss, West half

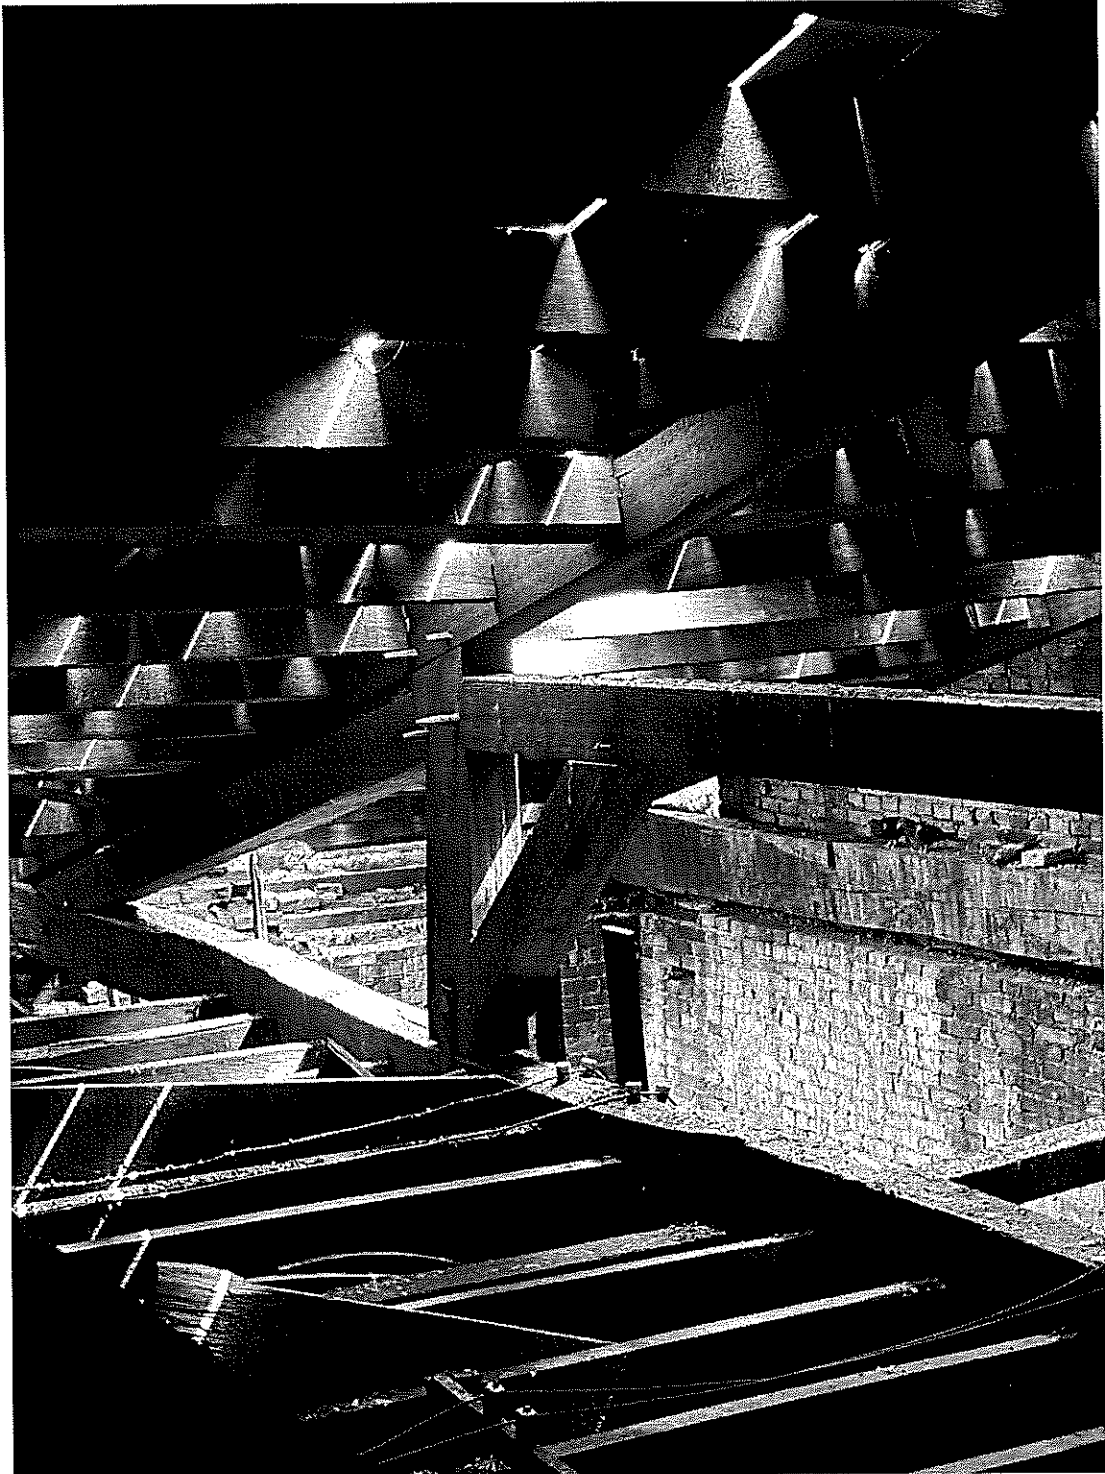
Except for the portions where the roof has failed, the roof structure appears to be in fair condition and appears to have performed well for a long time. The trusses bear on plates resting on the exterior brick walls, and there is no evidence of outward wall movement, which would be evident if trusses were not performing. In the area of the South Building where the roof system has failed and the structure has been left exposed to the elements, the building is in poor condition (Photo 15). The first truss in from the south wall has some moderate decay at the east bearing wall due to the prolonged exposure to the elements (Photo 16). Both the south wall and the south portion of the east wall have extensive damage due to long term exposure to excessive moisture (Photo 17, Photo 18). Adding to the deterioration of these walls, the presence of exterior wall coatings applied to the south

Photo 15 - South Building Truss at damaged roof

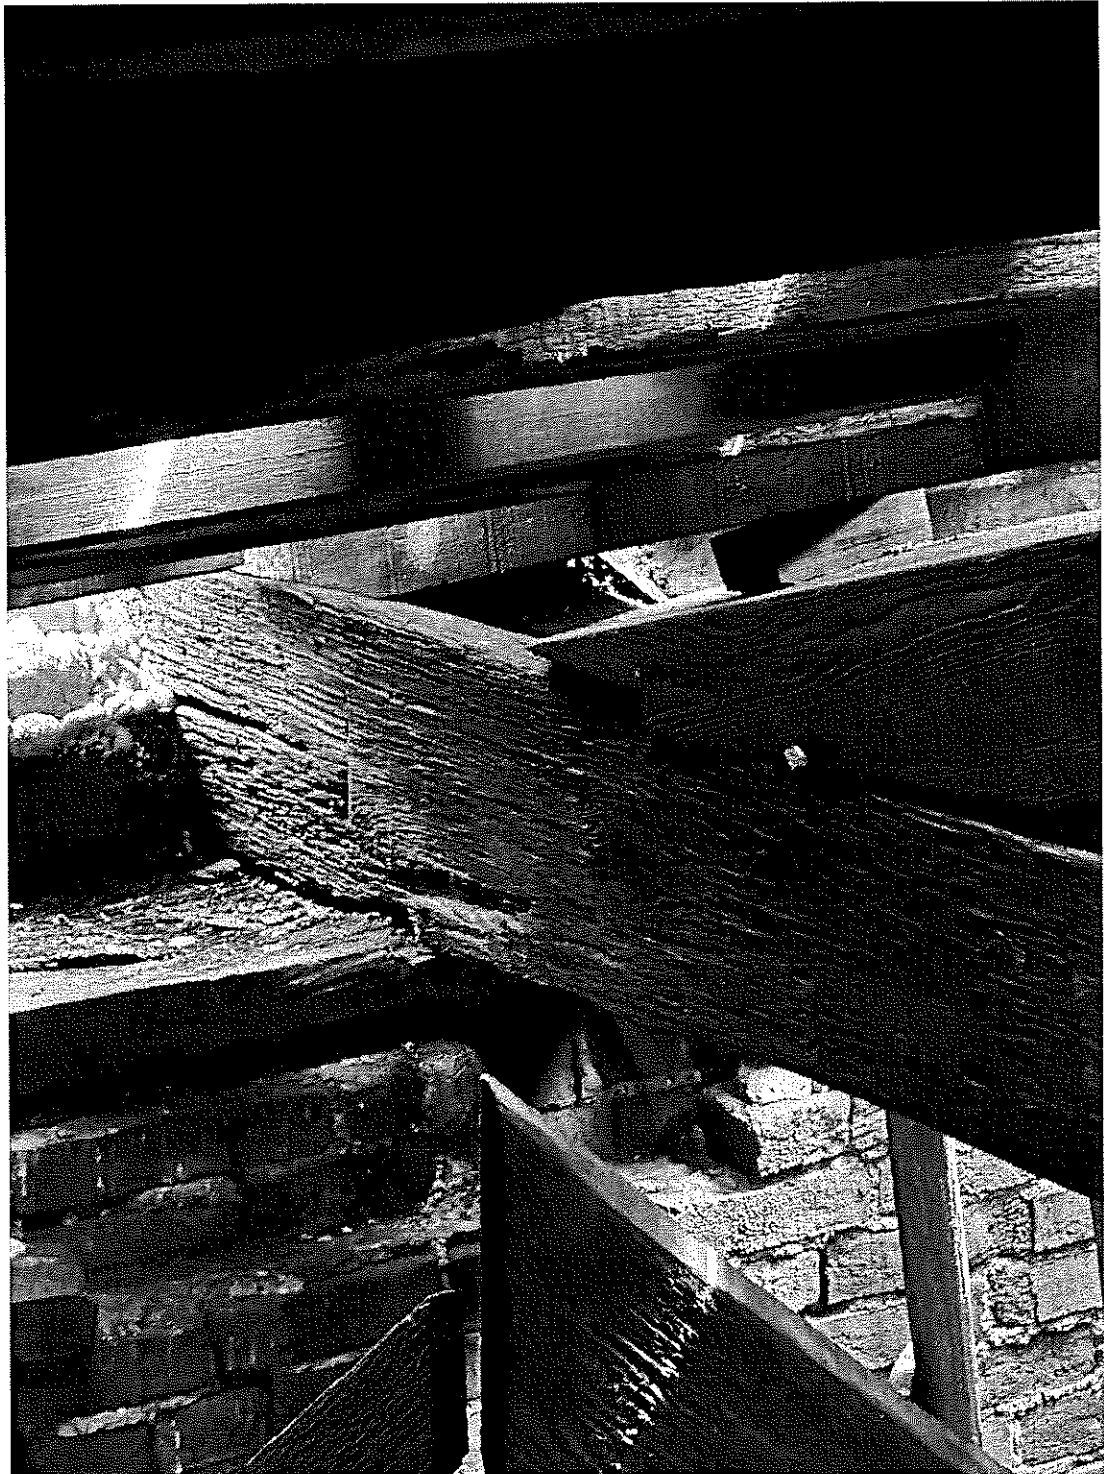
Photo 16 - South Building truss at wall bearing.

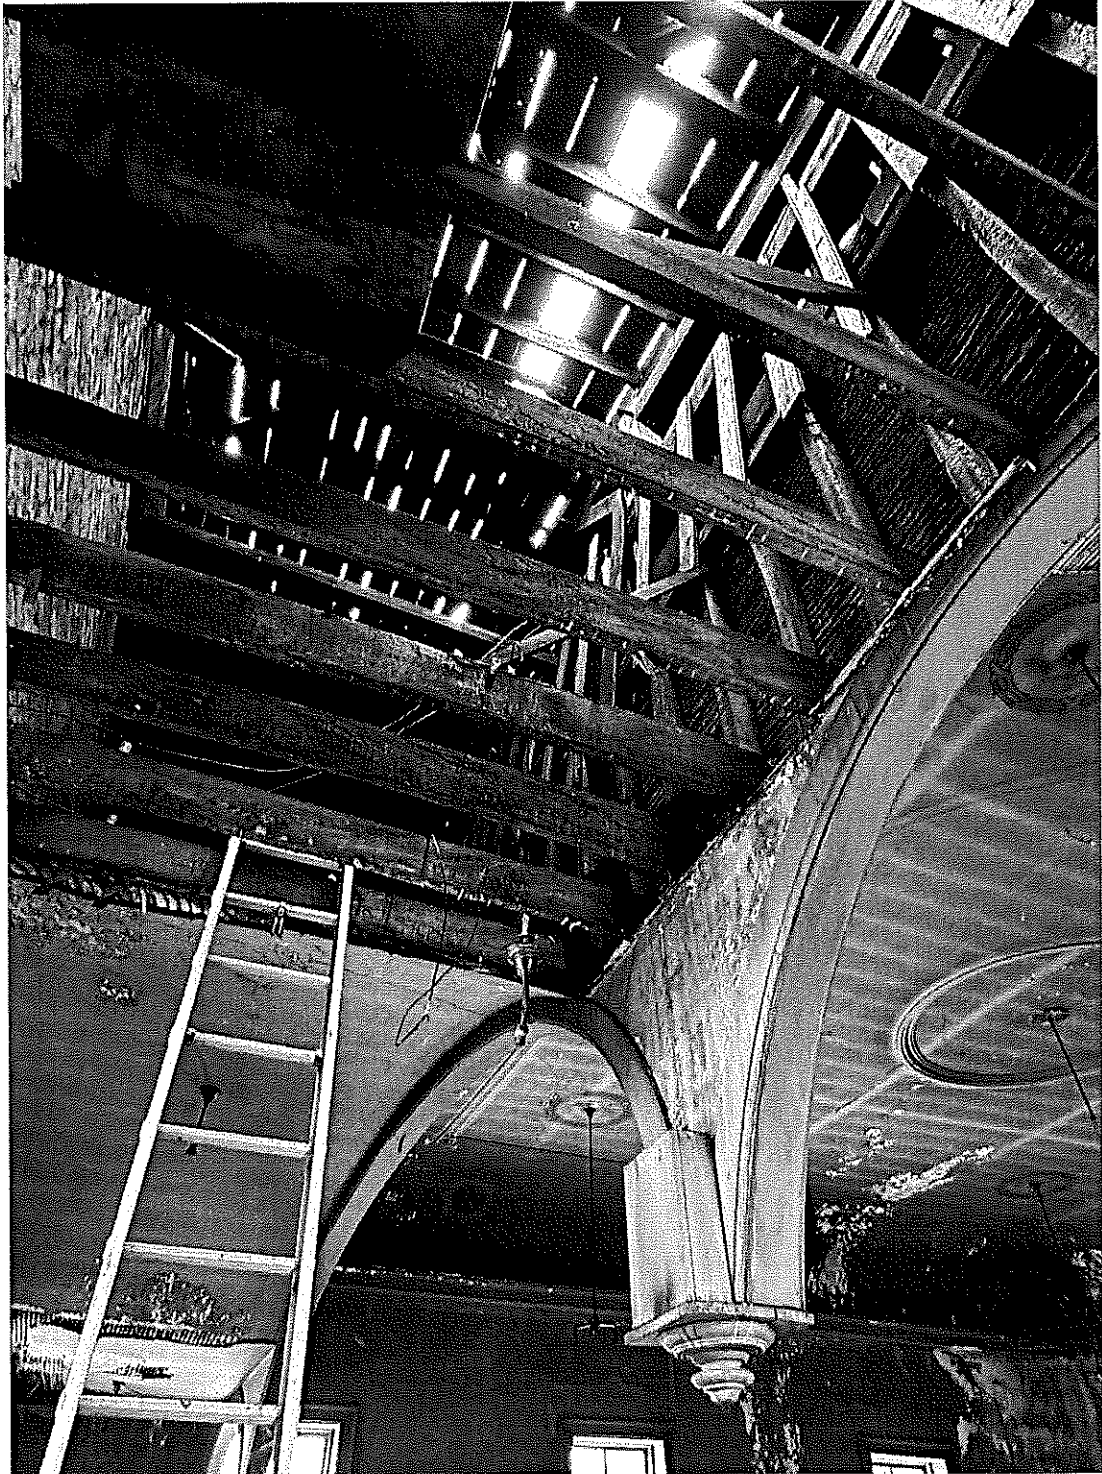
Photo 17 – South Building between South Wall and first roof truss

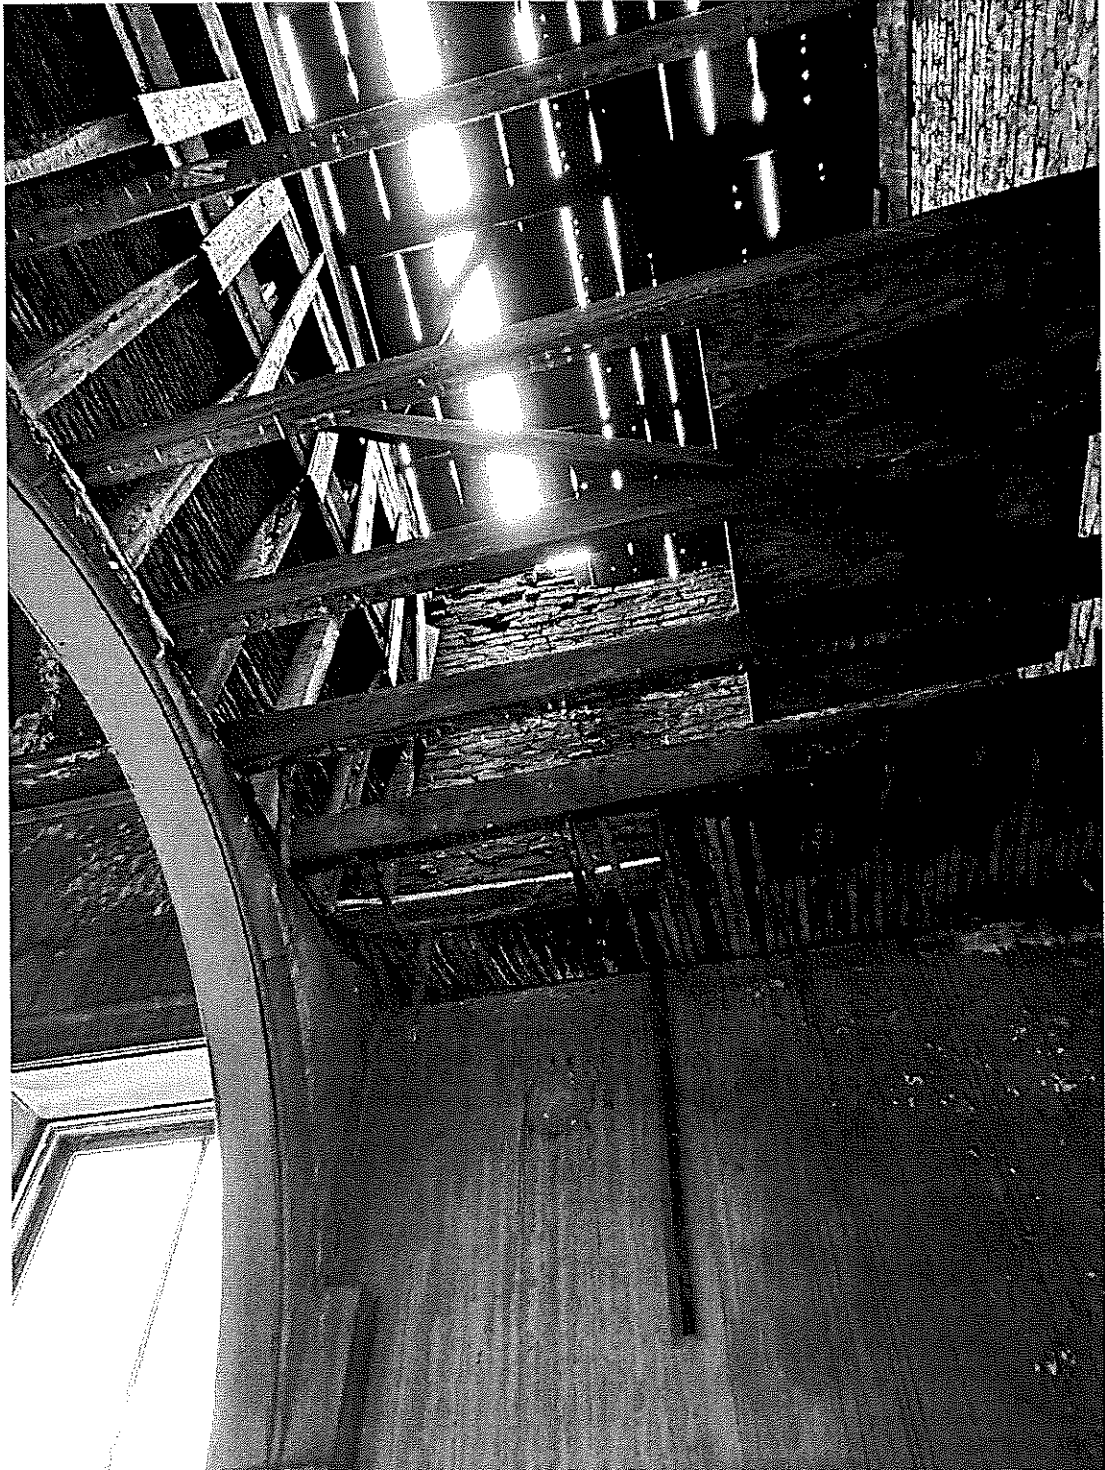
Photo 18 – South Building, south section of east wall damage.

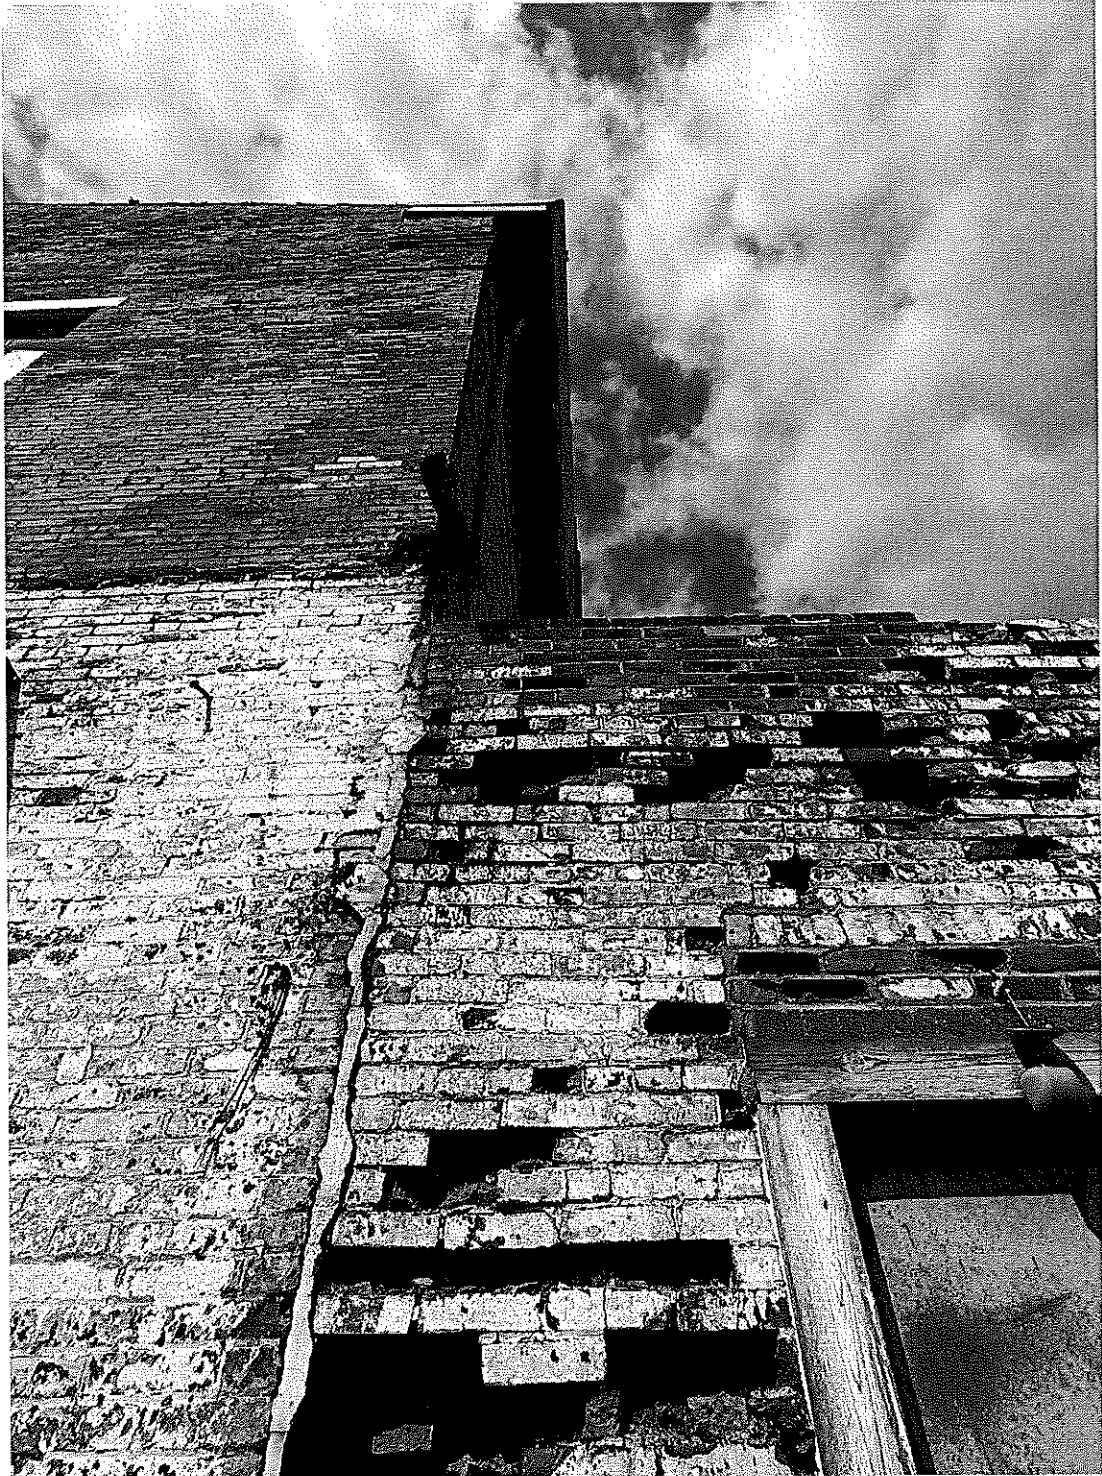
building walls have limited the ability for the mass masonry walls to breathe and release the excessive moisture trapped in the walls (Photo 19).

Photo 19 – South Building viewing Southeast Corner.
