IIOF building/old Miami County Courthouse – Window Replacement Application
Supplemental Report
September 18, 2024

Submitted by M. Chris Manning, Vice President of Troy Historic Preservation Alliance
Ms. Manning holds master degrees in historic preservation and archaeology with more than 20 years of experience in the two fields

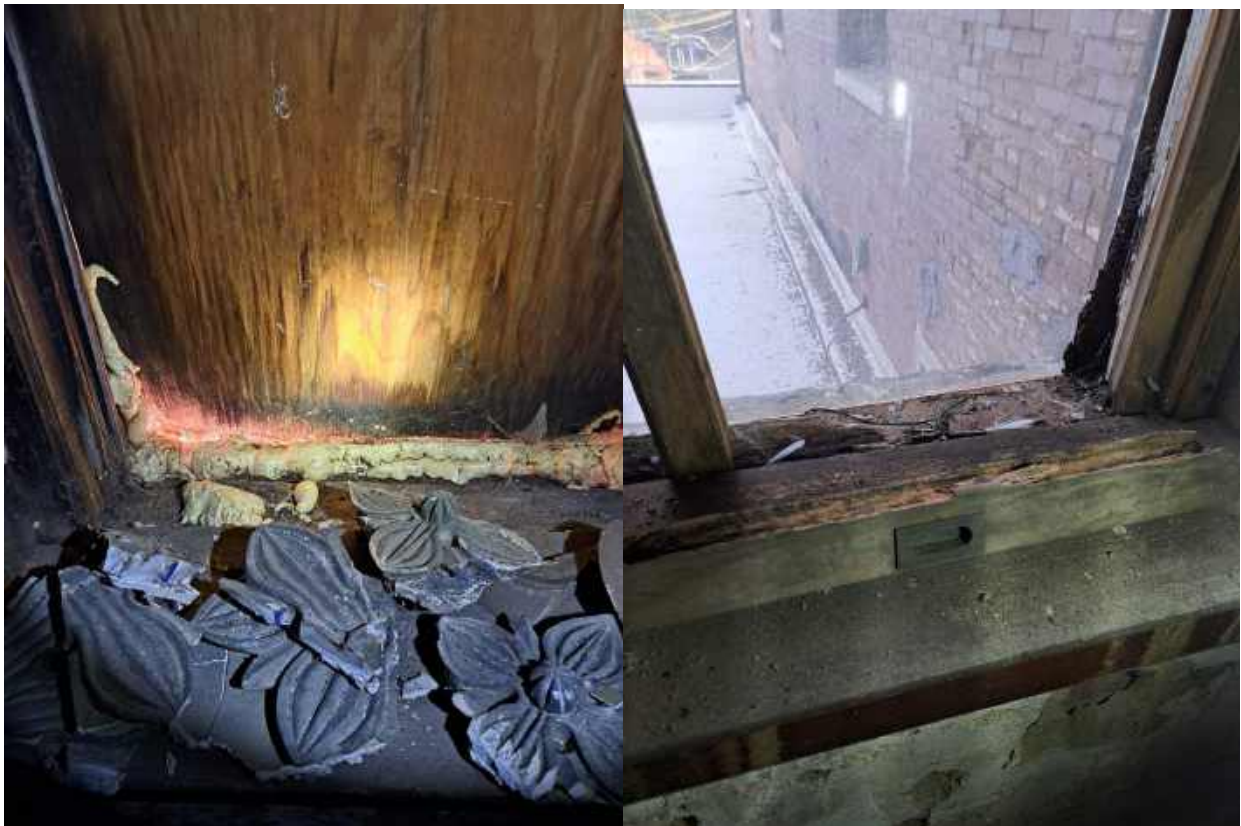
Window totally lost (boarded up)

Rail of window in SE elevation (bottom of window) has rotted off

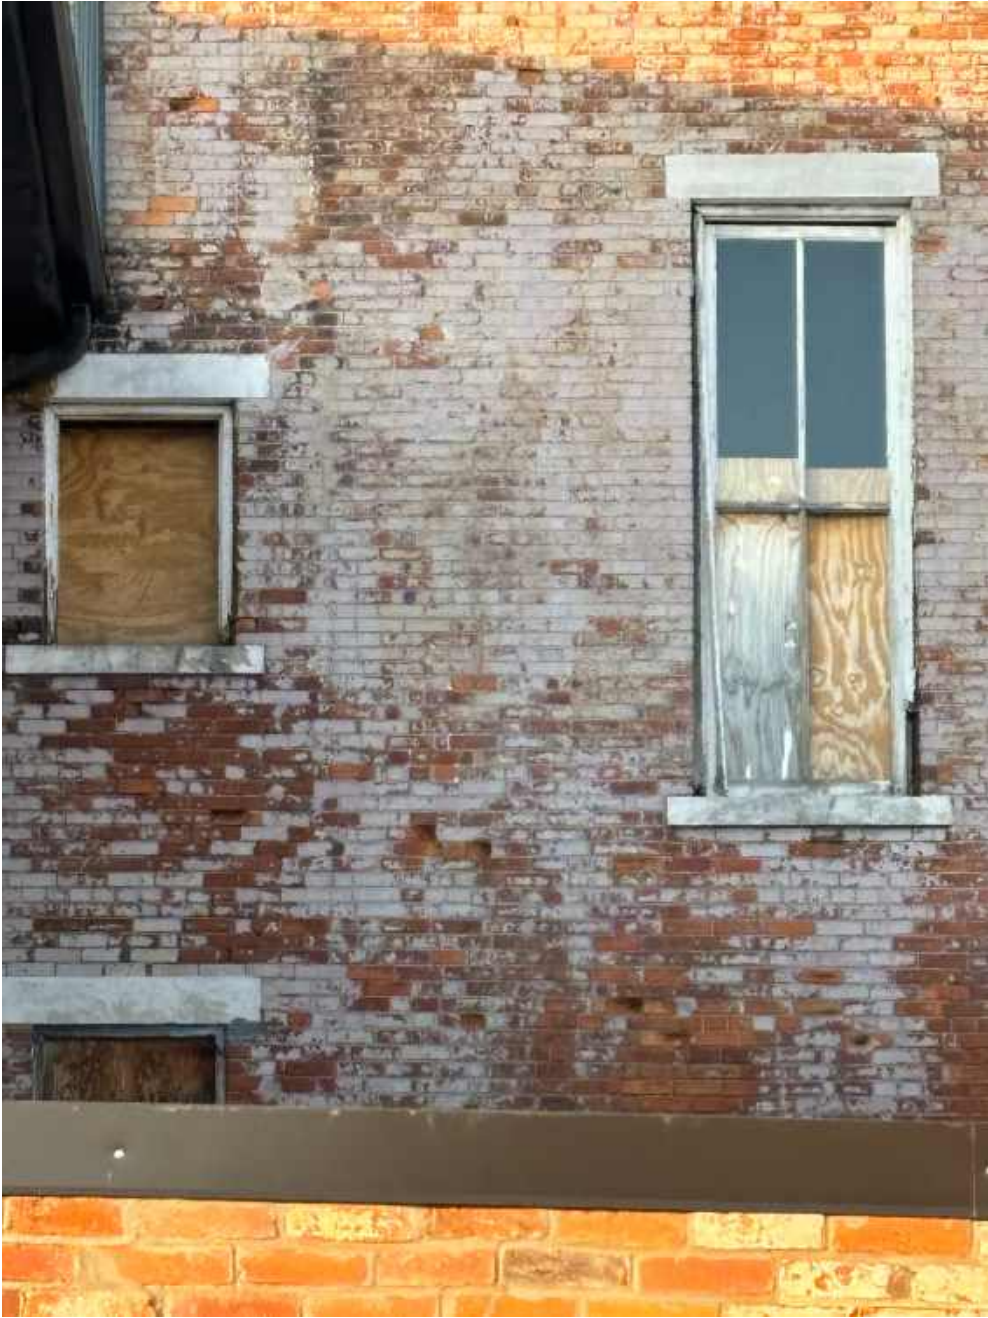
Exterior view of SE corner of IOOF building, showing window at left has been lost entirely and window at right has substantially rotted away at the bottom.

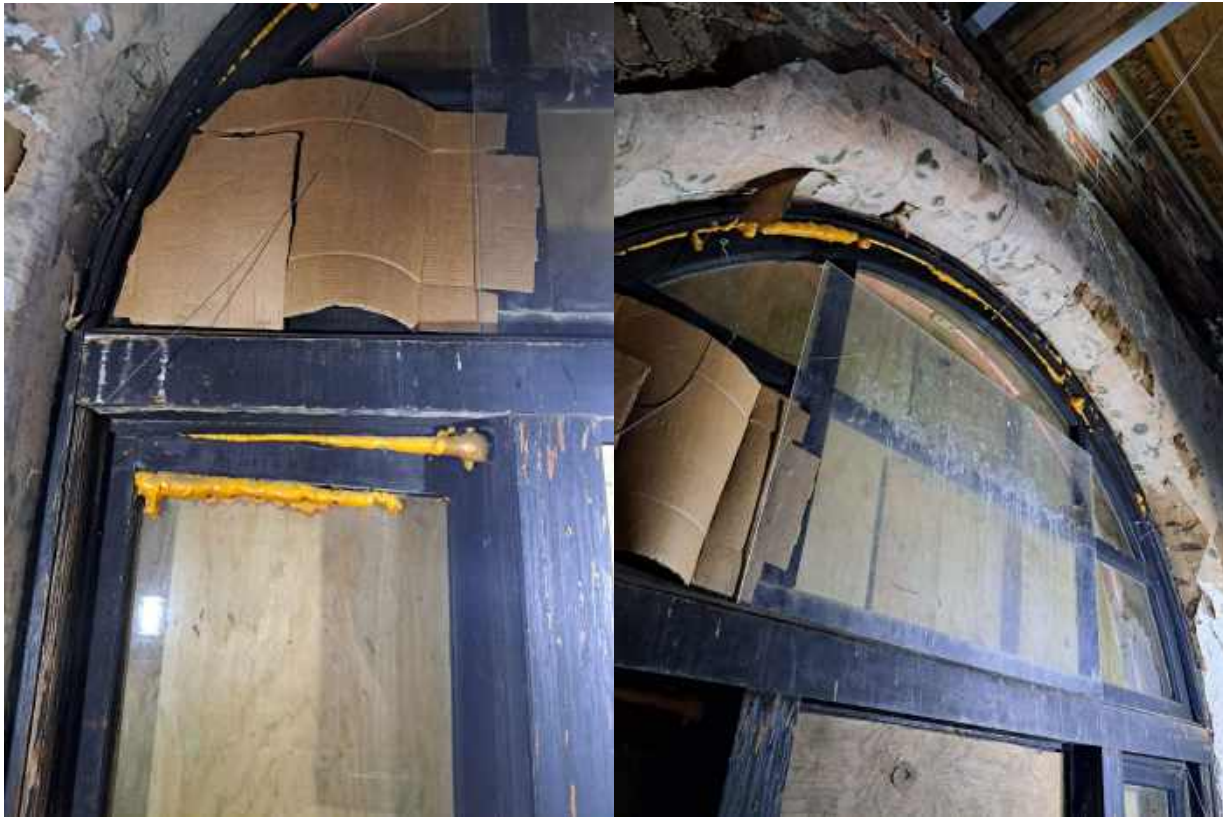
Third floor window of the IOOF building, showing deterioration of wood window frame (the spray insulation makes it clear how the sash is sagging as it rots in place). Note that a single wire suspended from a ceiling rafter is helping to hold this window frame in place.

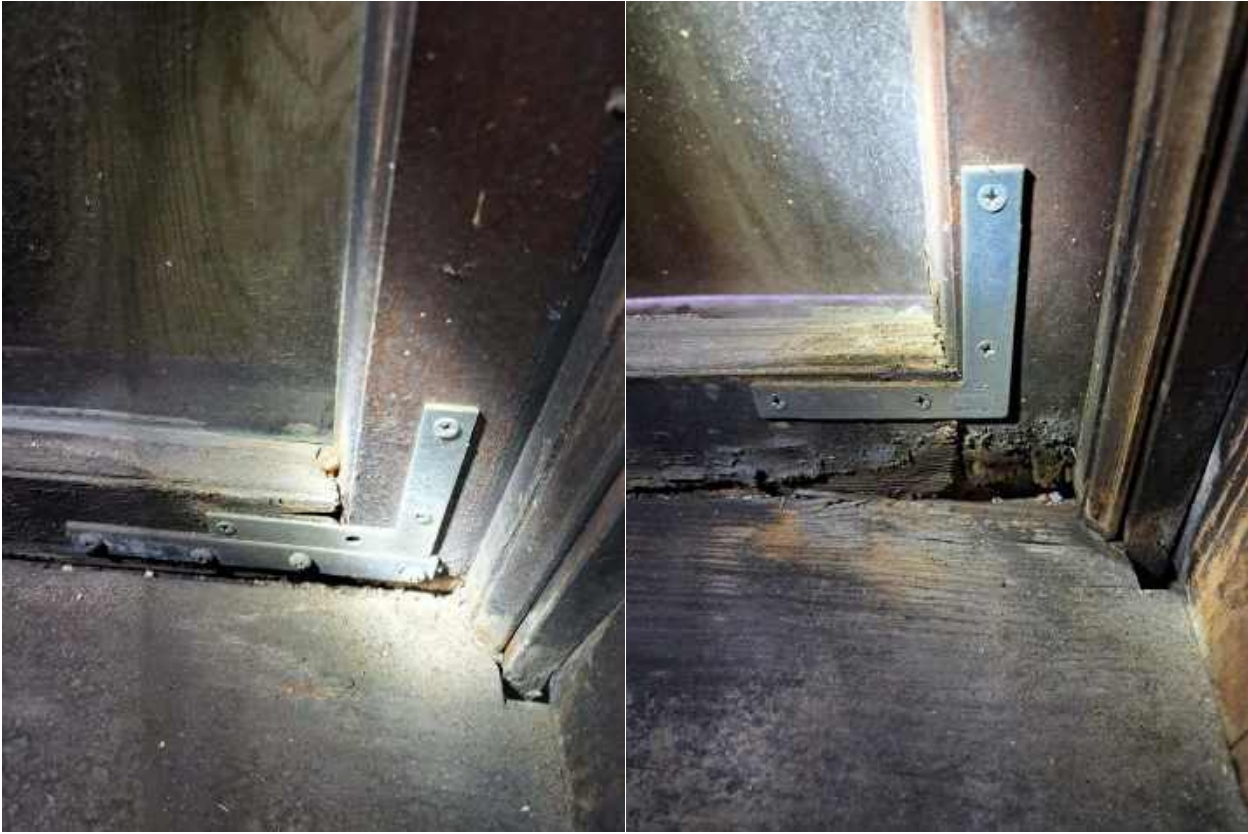
Many of the windows on the second and third floor of the north elevation of the IOOF building have had to be braced in places to hold them together.

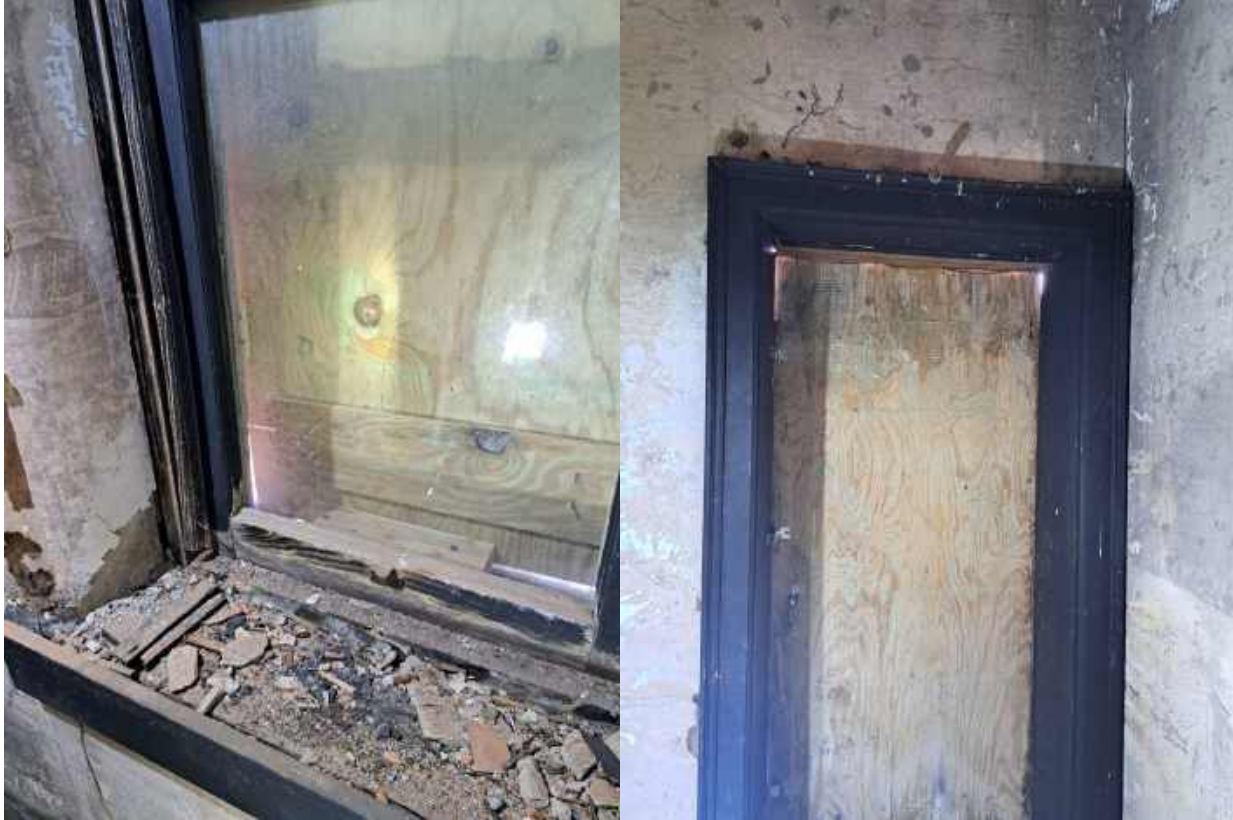
In the lower left photo, taken on the third floor of the IOOF building, the window sill had substantially rotted away, demonstrating the consequences of extensive water infiltration. The lower right photo shows there is no longer a door to the fire escape in the southwest corner of the third floor of the IOOF building.

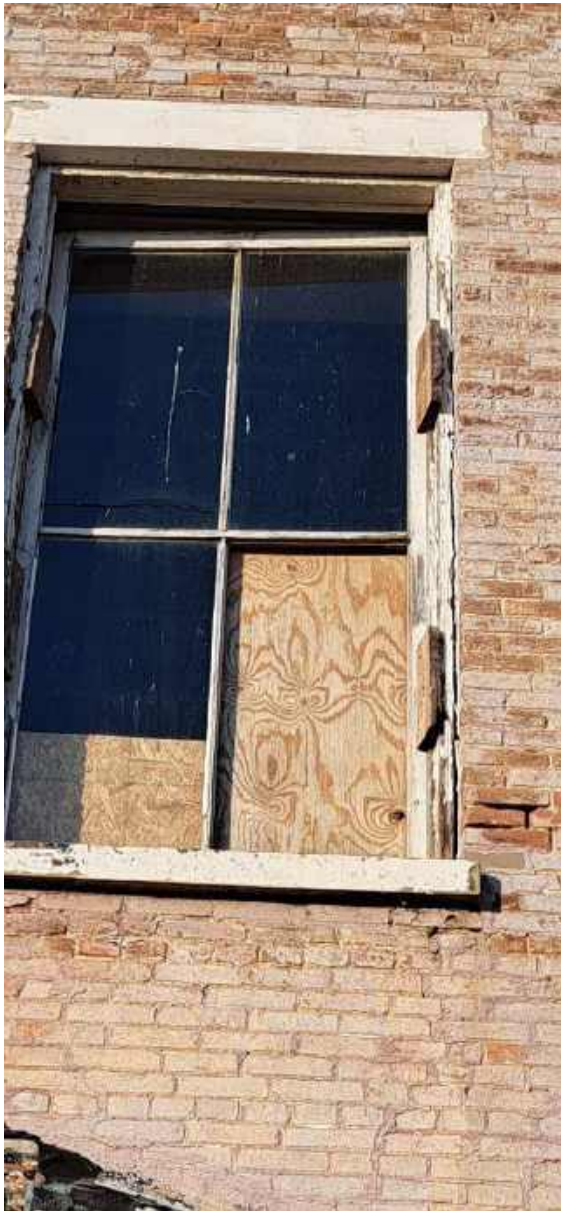
In the historic courthouse, photographic evidence has confirmed that the windows in the courtroom are no more than 70 years old (in a 182-year-old building). While these windows are

younger, they, too, have deteriorated and several have had to be boarded up. The proposed replacements with like materials would restore the mid-19th century look of the old courthouse.

The replacement of windows with like materials when repair would be difficult is consistent with the U.S. Secretary of Interior standards for the treatment of historic properties.
