Pedestrian Safety Review

Main St & Market St, City of Troy, Ohio

November 2021, Revised May 31, 2022

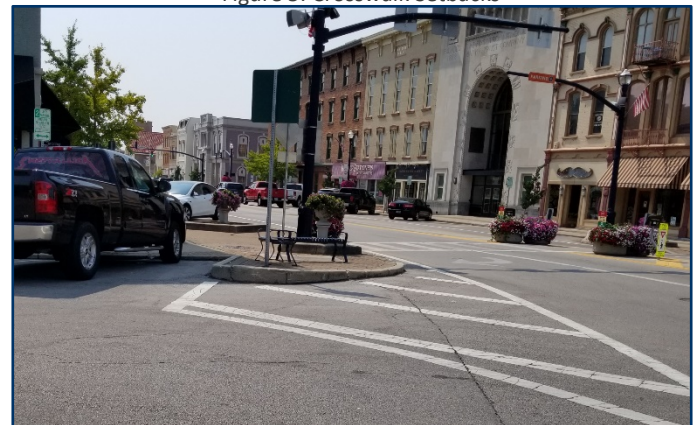
Figure 6: Sight distance looking left out of corner parking areas

The parking within the square, with entrance and exit drives directly onto the roundabout is not conventional, and does cause some crashes, particularly at the exit drives, with very limited sight distance to the left (Figure 6). Crashes backing in and out of spaces in the parking areas are low-speed, property damage only.

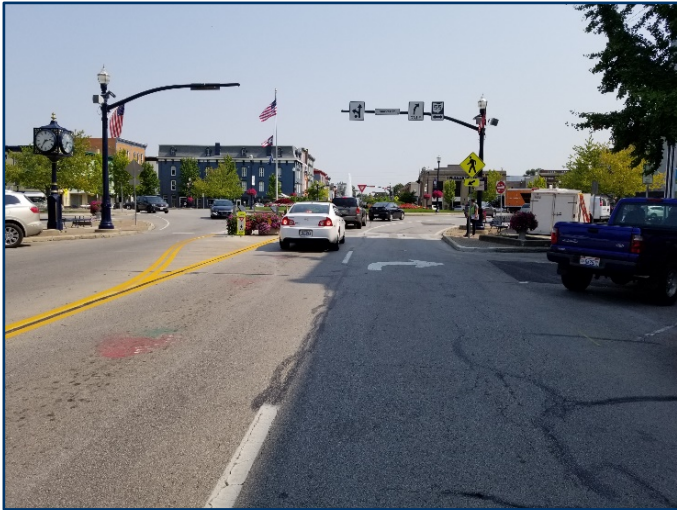
Figure 7: EB Right Turn Lane

The existing right turn lane design forces drivers to make a lane choice right at the crosswalk on three of the four approaches; the eastbound right turn lane is the only approach that introduces the right turn lane in advance of the crosswalk (Figure 7). Not only does this increase the crossing distance for pedestrians in the crosswalk, but it also increases the decisions drivers must make in the vicinity of the crosswalk. The longer crossing distance is exacerbated by the design of the existing curb bump outs, which do not extend fully out to the right turn bays (Figure 8).

Similarly, pedestrians waiting to cross are hidden from view if larger vehicles are parked in the angled on-street parking in the spaces closest to the crosswalk (Figure 7). While sight distance for the approaching driver to the crosswalk is adequate when those spaces are empty or occupied by compact vehicles, the sight distance is substantially reduced when SUVs, trucks, and other large vehicles are parked. Drivers often can't see pedestrians at the curb until they are at the crosswalk or just ahead of it.

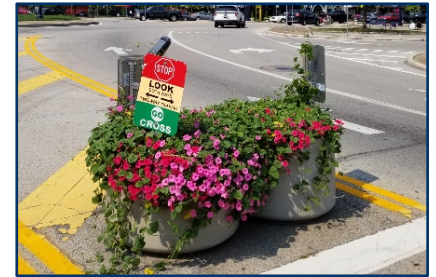
Figure 9: Median Planters

The biggest noticeable safety concern for pedestrians in the study area was limited visibility, both in terms of visual obstruction by physical objects and sight distance restrictions. As drivers approach the crosswalk, pedestrians waiting to cross and/or already in the crosswalk should be the only thing a driver sees. In the field, it was noted that concrete planters in the median and at the curb obscure the view of pedestrians. While the planters (Figure 8) improve aesthetics in the area, they are not standard traffic control devices meant to protect pedestrians within the roadway. The height of the flowers during the site visit proved to greatly obscure a 5'-7" adult pedestrian (Figure 9) with the top of flowers at about chest level. Although a portion of an adult pedestrian can be seen if behind the planter, a child or a person in a wheelchair would be completely obstructed.

Concrete planters in the median do provide a physical identification of the crosswalk location, but the height should remain low – ideally less than 3 feet tall – to avoid distracting oncoming motorists from the most important thing they need to see – pedestrians crossing the roadway. Planters 3 to 5 feet tall not only physically block visibility of pedestrians in the roadway, they can also hinder visibility of pedestrians by adding to the “clutter” within the median. In other words, tall planters can hinder visibility of pedestrians, even if they don’t physically hide the pedestrian, just by their very presence and physical size.

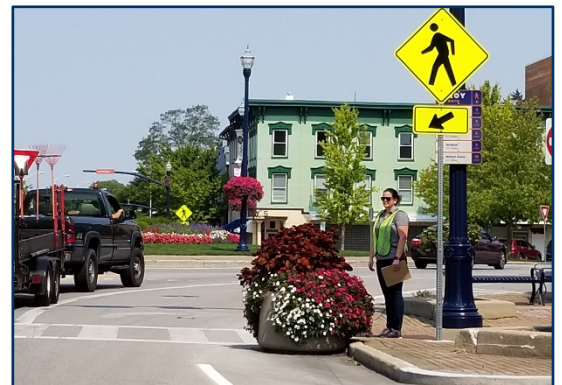
Figure 10: Curbside Planters

The crosswalk lines on the pavement are also very worn and faded. The flashing median crosswalk signs do serve as an active attention grabber to an unfamiliar driver in the area to warn them of the crosswalk. These flashing lights are more useful in the nighttime but could have the reverse effect on a driver that frequents the square since they flash constantly and drivers could start to ignore them.

The planters on the right side of the crosswalk (curbside) should be removed for the same reasons as noted above.

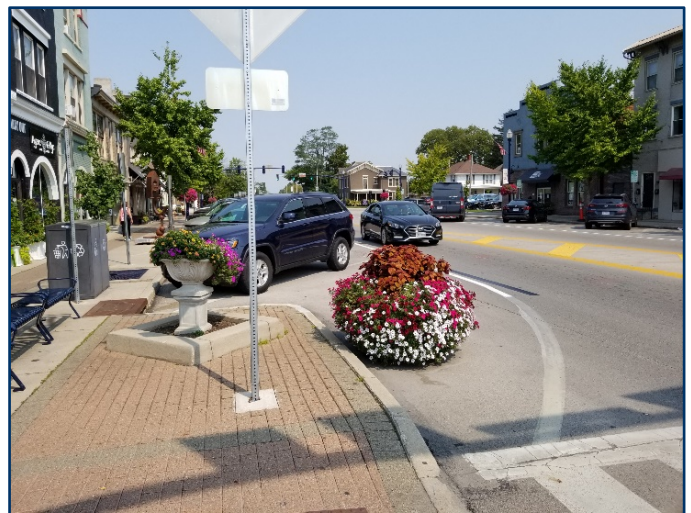
Figure 12: Available Curb Bump Out Space

Curb extensions, commonly called curb bump outs, reduce the effective crossing distance by extending the curb to the edge of the parking lane. The shortened crossing distance reduces the time pedestrians spend in the crosswalk, improves pedestrian visibility, and contributes to traffic calming by reducing roadway width. Existing curb bump outs are provided on some of the approaches to the roundabout but do not extend the full width of the parking stalls. If right turn lanes were removed, the curb bump outs could be extended even further. See Figure 12 showing distance from the edge line to the curb line. The curb line would be reconstructed to be at the edge line without a planter, decreasing the pedestrian crossing distance and increasing the visibility of the pedestrian.

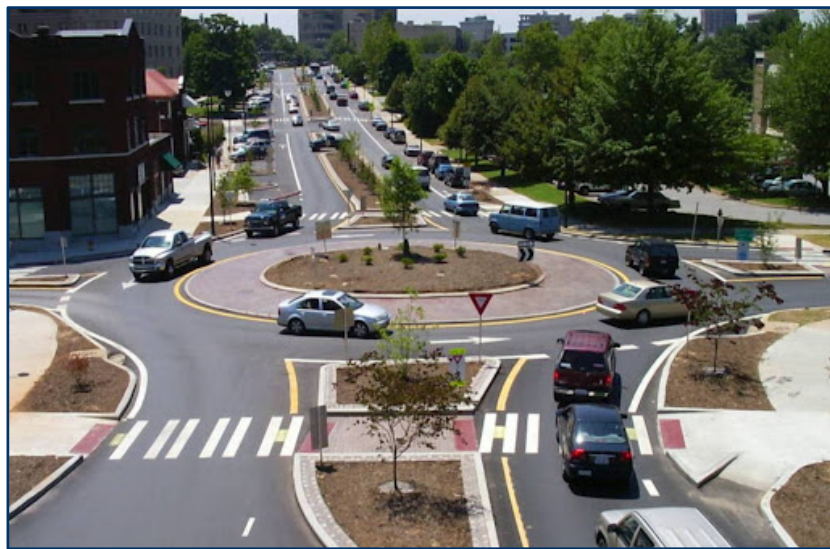
Figure 13: Pedestrian Refuge Islands (Source: FHWA)

According to the Federal Highway Administration (FHWA), pedestrian refuge areas at pedestrian crossings with marked crosswalks have been shown to reduce pedestrian crashes by 46%. Unlike typical midblock crossings and signalized intersections, gaps in traffic at roundabouts can be unpredictable and it can be difficult for pedestrians to decide when to cross. With refuge islands, pedestrians only need to cross one direction of traffic at a time and are provided a safe waiting space in the median. Refuge islands also provide physical barriers for visually impaired pedestrians to indicate they have reached a median. Figure 13 shows a typical application of refuge islands at a roundabout. Pedestrian refuge islands require a raised splitter island that can be landscaped with grass or other low-level vegetation. Construction of pedestrian refuge islands could be completed in 3 to 5 years in conjunction with the City’s downtown streetscape refresh/reconstruction plan.

Refuge islands also act as speed reducers for vehicles by providing physical boundaries compared to striped splitter islands.

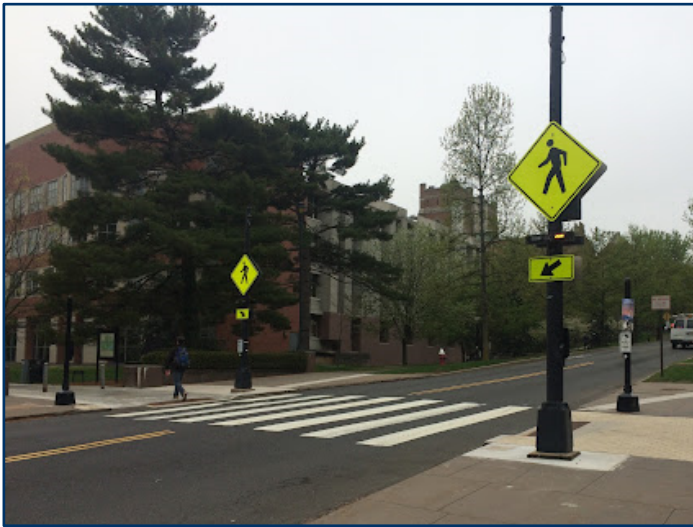
Figure 14: RRFB (Source: FHWA)

RRFBs are used in combination with pedestrian warning signs to provide higher visibility warning to drivers when pedestrians are using the crosswalk. According to FHWA, installation of RRFBs can reduce pedestrian crashes by 47% at uncontrolled pedestrian crossing locations. RRFBs are generally actuated by a pedestrian button and the flashing time is determined by crossing speed/distance. They are intended to increase pedestrian crossing visibility but do not prohibit vehicles from passing when pedestrians have cleared the crosswalk. Figure 14 shows a typical application of RRFBs and Figure 15 shows a proposed application at The Square (flashers off).

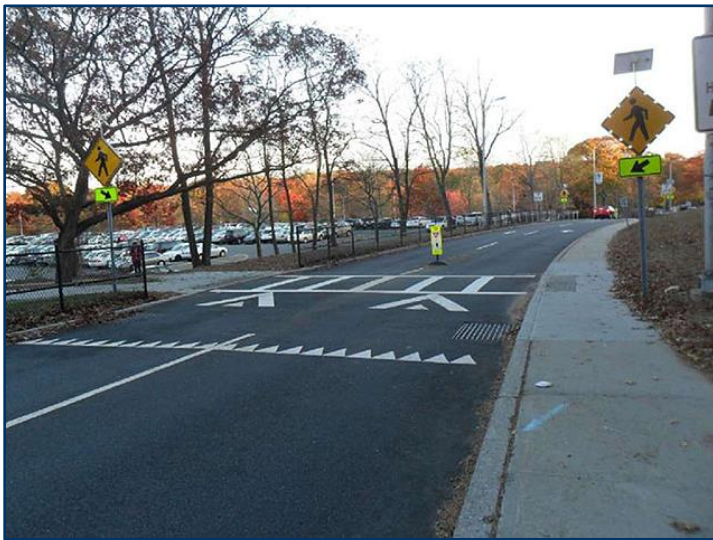
Figure 2: Raised Crosswalk (Source: FHWA)

Raised crosswalks are ramped speed tables that allow pedestrians to cross at grade with the sidewalk and act as traffic calming devices. They lower vehicle speeds and improve yielding at crosswalks, and per FHWA they reduce pedestrian crashes by 45%. Figure 2 shows a typical application of raised crosswalks and Figure 1 shows a local application of raised crosswalks at a roundabout in Hilliard, OH.

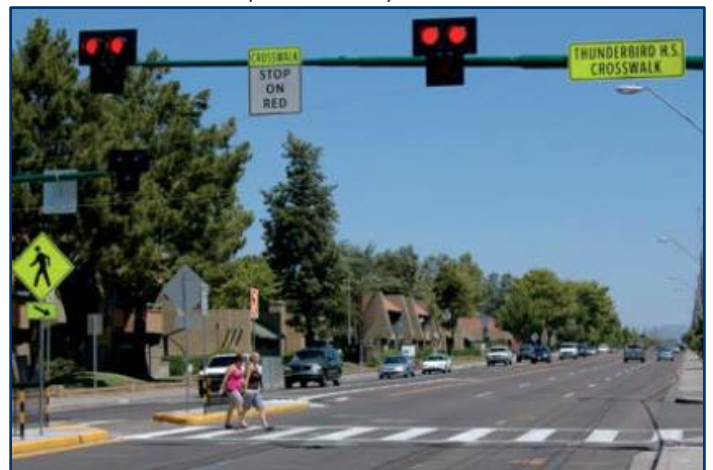
Figure 3: Pedestrian Hybrid Beacon (Source: FHWA)

Pedestrian hybrid beacons are like RRFBs in that they are actuated by pedestrians and increase visibility. Hybrid beacons, however, are mast arm mounted over the crosswalk and further increase invisibility beyond RRFBs. They have been shown to reduce pedestrian crashes by 69% and overall crashes by 29% (rear end collisions are reduced for vehicles stopping suddenly when pedestrians cross). Figure 3 shows a standard pedestrian hybrid beacon.

Unlike RRFBs, which are still relatively new and only have interim approval, hybrid beacons have been accepted by most regulating agencies; the MUTCD provides warrant criteria for the use of PHBs based on peak hour vehicular and pedestrian volumes. Using the traffic volumes collected from the intersection videos, the warrant analysis was completed for the midday peak and PM peak. The warrants showed that only the north leg crosswalk warranted a PHB in the PM peak hour,

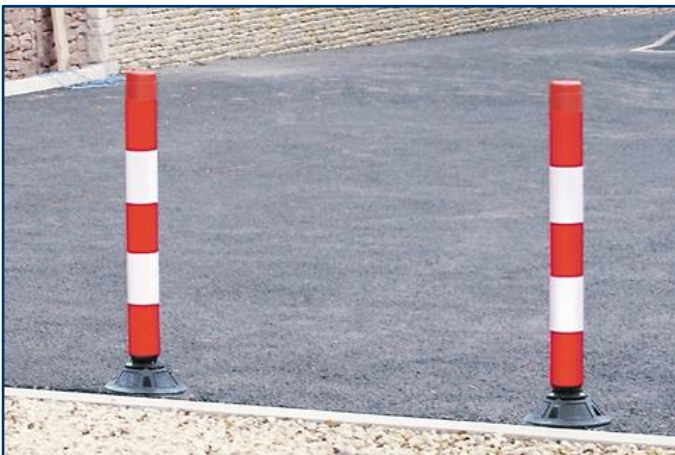
Figure 5: Flexible Traffic Pylons (Source: Barrier Solutions)

While the existing planters in the striped splitter islands offer projection to pedestrians waiting to cross, they also reduce the visibility of the pedestrian to approaching drivers. Flexible traffic pylons would provide similar delineation without the decreased visibility. Additionally, the pylons can be driven over if required for large truck turns, farm equipment, or in case of emergency vehicles needing space to get around traffic backups. Figure 5 shows flexible traffic pylons being used at crosswalks. Alternatively, the existing planters could be replaced with smaller planters to maintain the aesthetic but improve visibility of pedestrians waiting to cross.

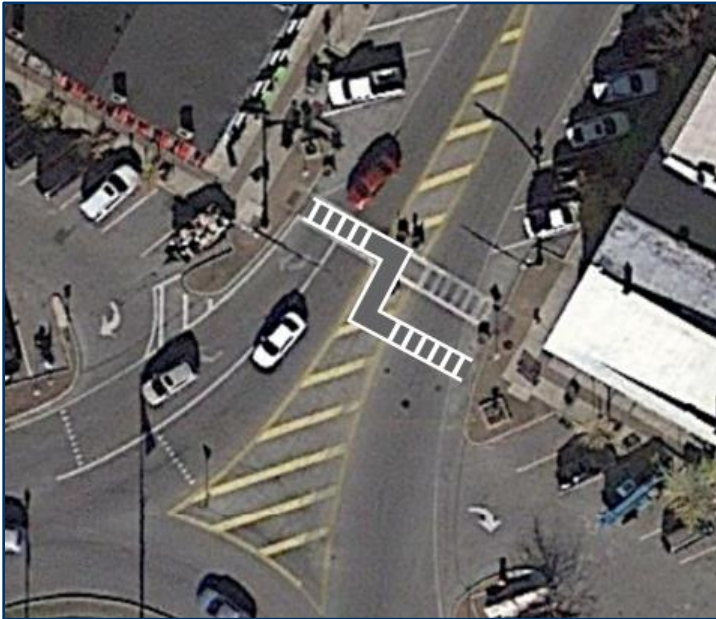
Figure 6: Zig Zag Crosswalk

Crosswalks are generally preferred to be located one-vehicle length behind the roundabout yield lines to reduce stop-start patterns for vehicles. Rather than slowing at the crosswalk and again at the yield line, vehicles can slow for both simultaneously. A minimum of one-vehicle length is required to provide space for a vehicle exiting the roundabout to wait for pedestrians crossing. Figure 7 shows typical pavement markings for a roundabout. Another option would be to move the curb ramp on the exiting leg and restripe the crosswalks with a “zig-zag” pattern; rather than crossing in one continuous segment, the crosswalk turns 90 degrees inside the pedestrian refuge island before crossing the second lane, as shown in Figure 6. A painted zig-zag crosswalk line though would be less likely to keep a pedestrian within the crosswalk and would be problematic to a visually impaired person, this is why curbing along the center area would be beneficial.

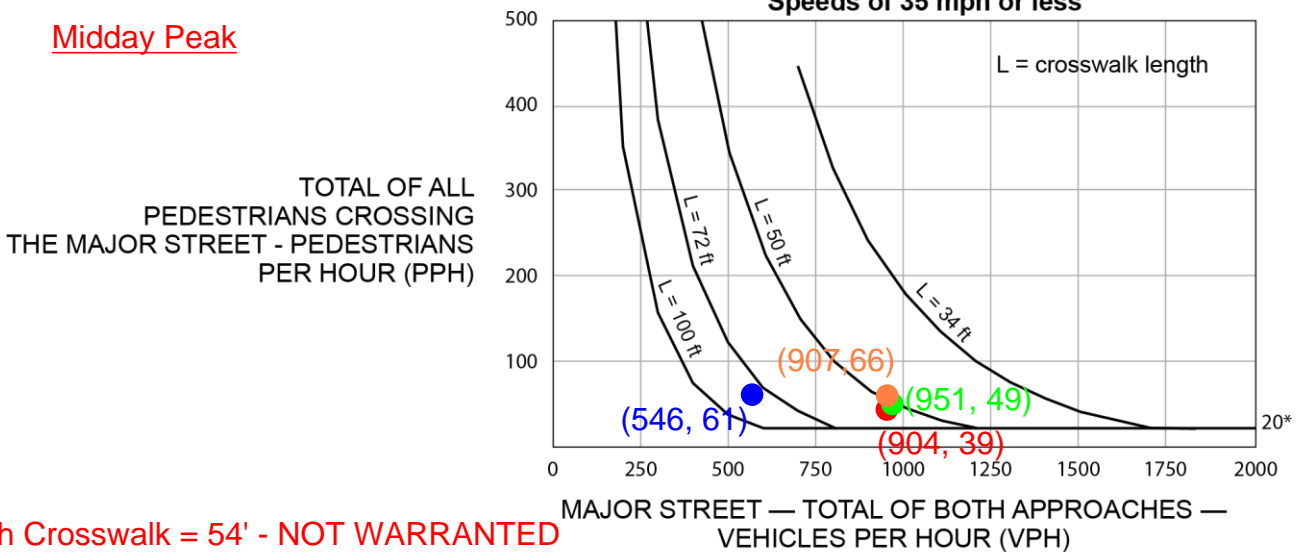
Figure 4F-1. Guidelines for the Installation of Pedestrian Hybrid Beacons on Low-Speed Roadways

- North Crosswalk = 54' - NOT WARRANTED
- East Crosswalk = 43' - NOT WARRANTED
- South Crosswalk = 41' - NOT WARRANTED
- West Crosswalk = 44' - NOT WARRANTED

* Note: 20 pph applies as the lower threshold volume

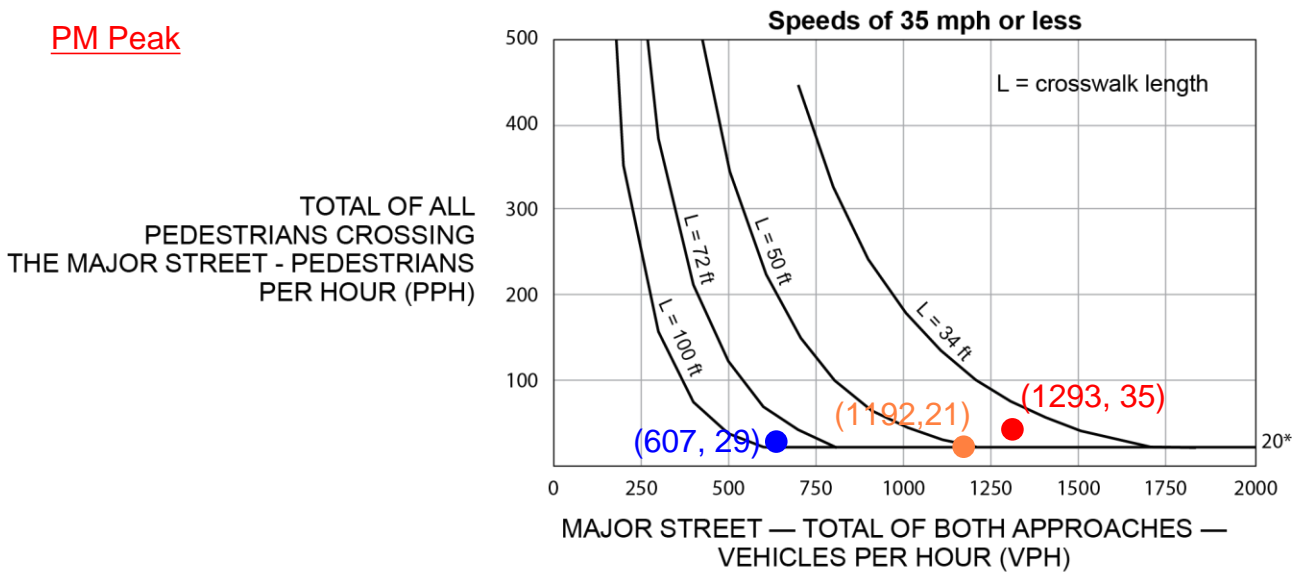
Figure 4F-1. Guidelines for the Installation of Pedestrian Hybrid Beacons on Low-Speed Roadways

- North Crosswalk = 54' - WARRANTED
- East Crosswalk = 43' - NOT WARRANTED
- South Crosswalk = 41' - NOT WARRANTED
- West Crosswalk = 44' - NOT WARRANTED
(18 peds < 20 minimum)

* Note: 20 pph applies as the lower threshold volume

primarily due to high vehicular volume crossing the walk. This matches the warrant that was completed as part of the 2017 Parking and Traffic Assessment. **Appendix D** includes the MUTCD warrant for a pedestrian hybrid beacon.
